Access Compliance Report

Public Rights-of-Way

(Curb Ramps)

Intersection ID: 49929	Main Street: ASHBOURNE_HALL_RD	Cross Street: CHAMBERLIN_RD	Location: SE
ADA ID: 75D70F5FD0F1	Ramp Type: Perp	Initial Pass/Fail: Fail	Overall Compliance: No
Severity Score: 12.5			
Codes/Mitigation Info/Possible Solution		Field Measurements/Component Compliance

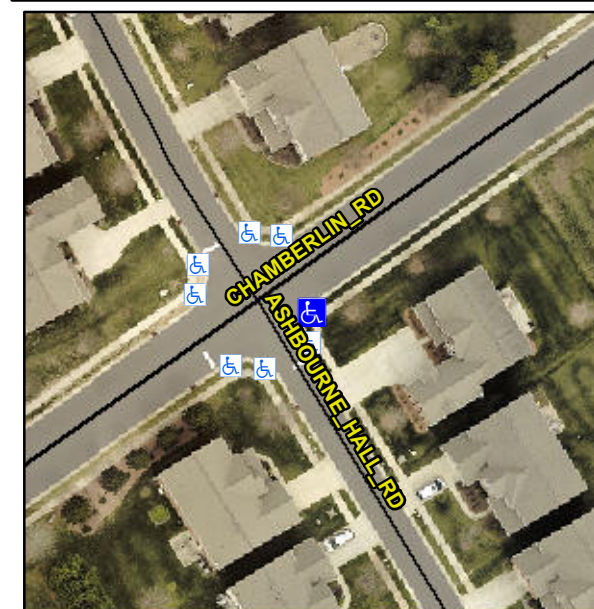
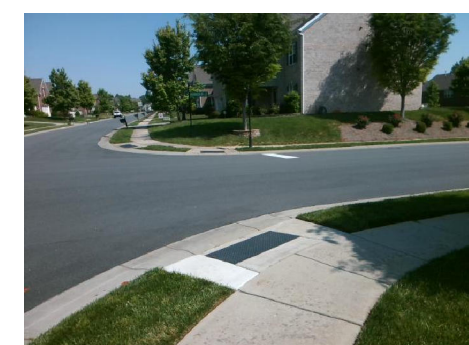
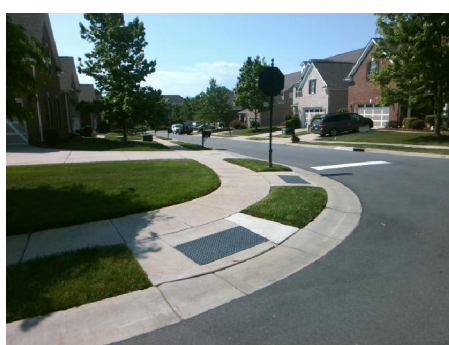
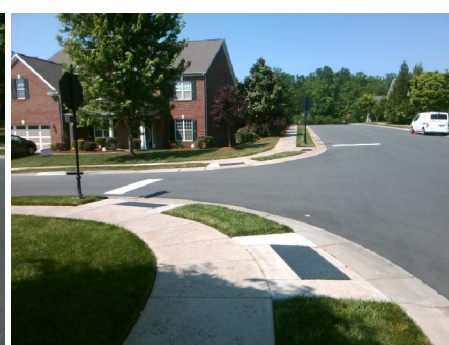
Not Found, R304.2.2

Compliance	Description	Data	Compliance	Description	Data
N/A	Ramp Length (in)	48.0	No	Ramp Slope (%)	10.9
Yes	Ramp Width (in)	48.0	Yes	Ramp XSlope (%)	0.4
N/A	Flare Type LT	N/A	N/A	Flare Type RT	N/A
N/A	Flare Slope LT (%)	N/A	N/A	Flare Slope RT (%)	N/A
N/A	Flare Traversable LT?	N/A	N/A	Flare Traversable RT?	N/A
N/A	Landing Length (in)	N/A	N/A	DWS Provided?	N/A
N/A	Landing Width (in)	N/A	N/A	DWS Contrast?	N/A
N/A	Landing Slope (%)	N/A	N/A	DWS Length (in)	N/A
N/A	Landing X Slope (%)	N/A	N/A	DWS Full Width?	N/A
N/A	Landing Curb? (Y/N)	N/A	N/A	DWS Offset (in)	N/A
N/A	Shared Landing?	N/A			
N/A	Gutter Ponding?	N/A	N/A	Gutter Slope (%)	N/A
N/A	Gutter Lip Ht (in)	N/A	N/A	Gutter X Slope (%)	N/A
N/A	Painted X Walk1?	No	N/A	Painted X Walk2?	N/A
	X Walk 1 Direction	To NW		X Walk 2 Direction	N/A
N/A	X Walk 1 Width (in)	N/A	N/A	X Walk 2 Width (in)	N/A
	X Walk 1 Slope (%)	4.0		X Walk 2 Slope (%)	N/A
	X Walk 1 X Slope (%)	2.7		X Walk 2 X Slope (%)	N/A

N/A	Ramp inside XWalk1?	N/A	N/A	Ramp inside XWalk2?	N/A
	Road Slope (%)	N/A	N/A	Clear Space?	N/A
	Road X Slope (%)	N/A	N/A	Clear Space to XWalk (in)	N/A
N/A	Any Obstructions?	N/A	N/A	Storm Grate/Utility Hazard?	N/A
	Obstruction Type			Storm Grate/Utility Type	
		N/A			N/A
			Yes	Surface Condition? (G/P)	Good

Remove & Replace Entire Ramp.
