Access Compliance Report

Public Rights-of-Way

(Curb Ramps)

Intersection ID: 30125	Main Street: CLOONEY_LN	Cross Street: RUMPLE_RD	Location: SE
ADA ID: 75DB7848D3D5	Ramp Type: Perp	Initial Pass/Fail: Fail	Overall Compliance: No
Severity Score: 21.25			
Codes/Mitigation Info/Possible Solution		Field Measurements/Component Compliance

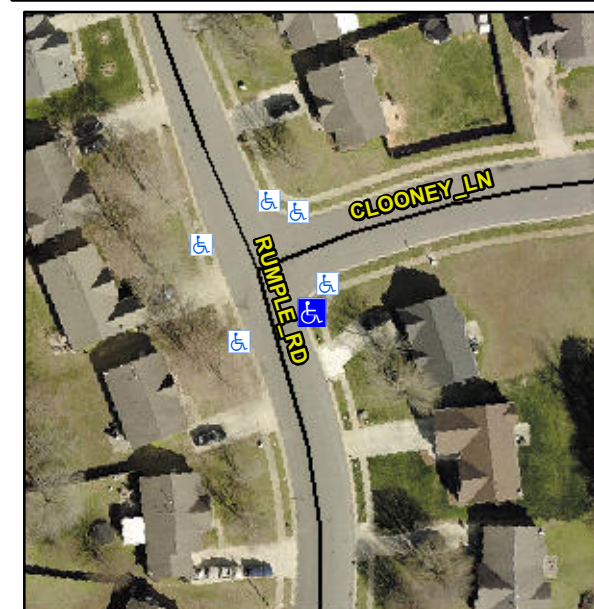
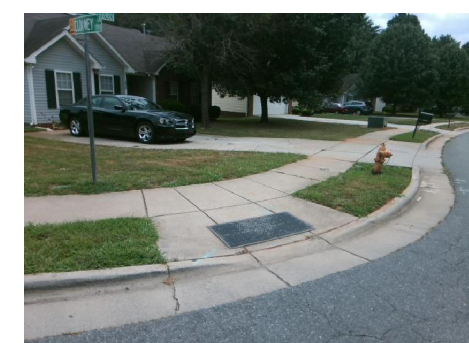
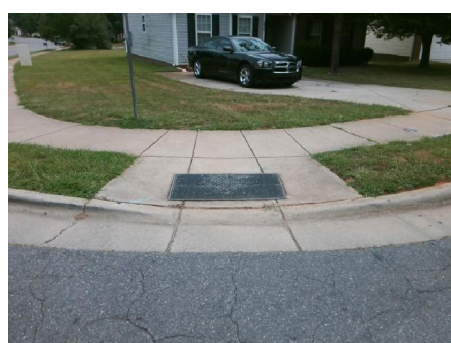
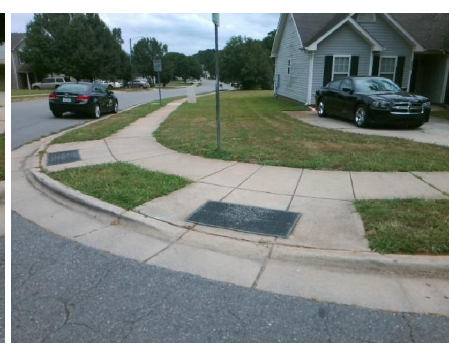
Not Found, R304.5.1, R304.2.2

Compliance	Description	Data	Compliance	Description	Data
N/A	Ramp Length (in)	49.0	No	Ramp Slope (%)	8.4
No	Ramp Width (in)	39.0	Yes	Ramp XSlope (%)	1.9
N/A	Flare Type LT	N/A	N/A	Flare Type RT	N/A
N/A	Flare Slope LT (%)	N/A	N/A	Flare Slope RT (%)	N/A
N/A	Flare Traversable LT?	N/A	N/A	Flare Traversable RT?	N/A
N/A	Landing Length (in)	N/A	N/A	DWS Provided?	N/A
N/A	Landing Width (in)	N/A	N/A	DWS Contrast?	N/A
N/A	Landing Slope (%)	N/A	N/A	DWS Length (in)	N/A
N/A	Landing X Slope (%)	N/A	N/A	DWS Full Width?	N/A
N/A	Landing Curb? (Y/N)	N/A	N/A	DWS Offset (in)	N/A
N/A	Shared Landing?	N/A			
N/A	Gutter Ponding?	N/A	N/A	Gutter Slope (%)	N/A
N/A	Gutter Lip Ht (in)	N/A	N/A	Gutter X Slope (%)	N/A
N/A	Painted X Walk1?	No	N/A	Painted X Walk2?	N/A
	X Walk 1 Direction	To W		X Walk 2 Direction	N/A
N/A	X Walk 1 Width (in)	N/A	N/A	X Walk 2 Width (in)	N/A
	X Walk 1 Slope (%)	2.9		X Walk 2 Slope (%)	N/A
	X Walk 1 X Slope (%)	0.5		X Walk 2 X Slope (%)	N/A

N/A	Ramp inside XWalk1?	N/A	N/A	Ramp inside XWalk2?	N/A
	Road Slope (%)	N/A	N/A	Clear Space?	N/A
	Road X Slope (%)	N/A	N/A	Clear Space to XWalk (in)	N/A
N/A	Any Obstructions?	N/A	N/A	Storm Grate/Utility Hazard?	N/A
	Obstruction Type			Storm Grate/Utility Type	
		N/A			N/A
			Yes	Surface Condition? (G/P)	Good

Possible Solutions:

Remove & Replace Entire Ramp.
