# Access Compliance Report

## Public Rights-of-Way

### (Curb Ramps)

Intersection ID: 15563	Main Street: GRANVILLE_RD	Cross Street: QUEENS_RD	Location: NE
ADA ID: 75DCE3E3086A	Ramp Type: Perp	Initial Pass/Fail: Fail	Overall Compliance: No
		Severity Score: 12.5

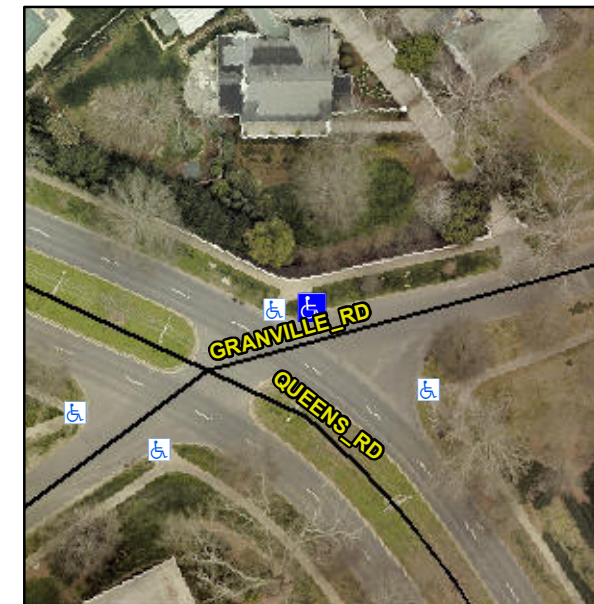
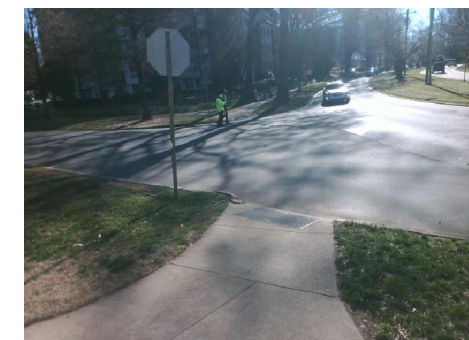
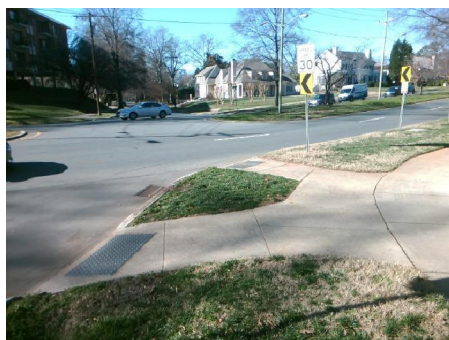
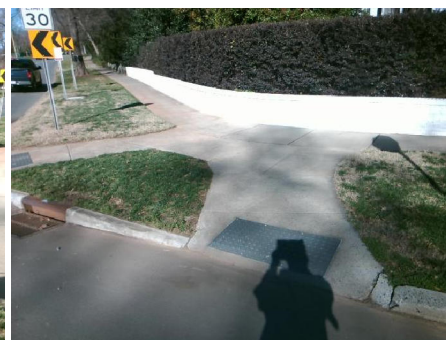
Compliance	Description	Data	Compliance	Description	Data
N/A	Ramp Length (in)	36.0	No	Ramp Slope (%)	10.3
Yes	Ramp Width (in)	48.0	Yes	Ramp XSlope (%)	0.1
N/A	Flare Type LT	N/A	N/A	Flare Type RT	N/A
N/A	Flare Slope LT (%)	N/A	N/A	Flare Slope RT (%)	N/A
N/A	Flare Traversable LT?	N/A	N/A	Flare Traversable RT?	N/A
N/A	Landing Length (in)	N/A	N/A	DWS Provided?	N/A
N/A	Landing Width (in)	N/A	N/A	DWS Contrast?	N/A
N/A	Landing Slope (%)	N/A	N/A	DWS Length (in)	N/A
N/A	Landing X Slope (%)	N/A	N/A	DWS Full Width?	N/A
N/A	Landing Curb? (Y/N)	N/A	N/A	DWS Offset (in)	N/A
N/A	Shared Landing?	N/A			
N/A	Gutter Ponding?	N/A	N/A	Gutter Slope (%)	N/A
N/A	Gutter Lip Ht (in)	N/A	N/A	Gutter X Slope (%)	N/A
N/A	Painted X Walk1?	No	N/A	Painted X Walk2?	N/A
	X Walk 1 Direction	To SE		X Walk 2 Direction	N/A
N/A	X Walk 1 Width (in)	N/A	N/A	X Walk 2 Width (in)	N/A
	X Walk 1 Slope (%)	2.6		X Walk 2 Slope (%)	N/A
	X Walk 1 X Slope (%)	1.9		X Walk 2 X Slope (%)	N/A

N/A	Ramp inside XWalk1?	N/A	N/A	Ramp inside XWalk2?	N/A
	Road Slope (%)	N/A	N/A	Clear Space?	N/A
	Road X Slope (%)	N/A	N/A	Clear Space to XWalk (in)	N/A
N/A	Any Obstructions?	N/A	N/A	Storm Grate/Utility Hazard?	N/A
	Obstruction Type			Storm Grate/Utility Type	
		N/A			N/A
			Yes	Surface Condition? (G/P)	Good

**Remove & Replace Entire Ramp.**
