Access Compliance Report

Public Rights-of-Way

(Curb Ramps)

Intersection ID: 18178	Main Street: HODGSON_RD	Cross Street: RANDOLPH_RD	Location:	N
ADA ID: 75DF9D084230	Ramp Type: PerpDiag	Initial Pass/Fail: Fail	Overall Compliance: No	Severity Score: 12.5

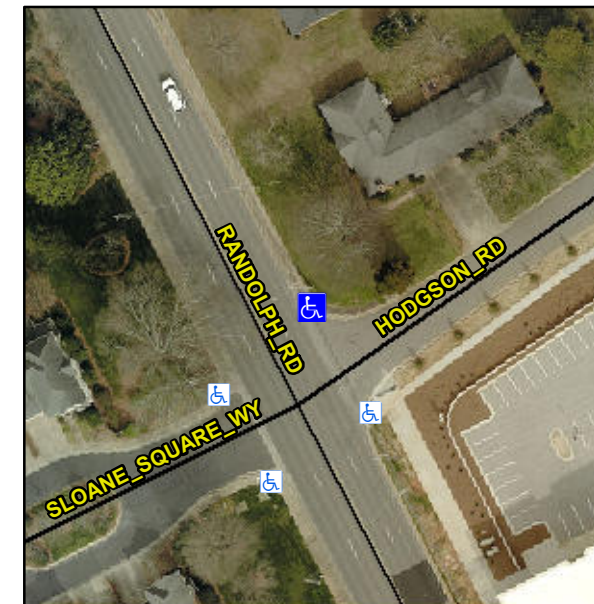
Not Found, R304.2.2

Compliance	Description	Data	Compliance	Description	Data
N/A	Ramp Length (in)	55.0	No	Ramp Slope (%)	10.0
Yes	Ramp Width (in)	48.0	Yes	Ramp XSlope (%)	1.9
N/A	Flare Type LT	N/A	N/A	Flare Type RT	N/A
N/A	Flare Slope LT (%)	N/A	N/A	Flare Slope RT (%)	N/A
N/A	Flare Traversable LT?	N/A	N/A	Flare Traversable RT?	N/A
N/A	Landing Length (in)	N/A	N/A	DWS Provided?	N/A
N/A	Landing Width (in)	N/A	N/A	DWS Contrast?	N/A
N/A	Landing Slope (%)	N/A	N/A	DWS Length (in)	N/A
N/A	Landing X Slope (%)	N/A	N/A	DWS Full Width?	N/A
N/A	Landing Curb? (Y/N)	N/A	N/A	DWS Offset (in)	N/A
N/A	Shared Landing?	N/A			
N/A	Gutter Ponding?	N/A	N/A	Gutter Slope (%)	N/A
N/A	Gutter Lip Ht (in)	N/A	N/A	Gutter X Slope (%)	N/A
N/A	Painted X Walk1?	No	N/A	Painted X Walk2?	No
	X Walk 1 Direction	To SW		X Walk 2 Direction	To SE
N/A	X Walk 1 Width (in)	N/A	N/A	X Walk 2 Width (in)	N/A
	X Walk 1 Slope (%)	1.6		X Walk 2 Slope (%)	0.8
	X Walk 1 X Slope (%)	0.3		X Walk 2 X Slope (%)	2.0

N/A	Ramp inside XWalk1?	N/A	N/A	Ramp inside XWalk2?	N/A
	Road Slope (%)	0.6	N/A	Clear Space?	N/A
	Road X Slope (%)	1.7	N/A	Clear Space to XWalk (in)	N/A
N/A	Any Obstructions?	N/A	N/A	Storm Grate/Utility Hazard?	N/A
	Obstruction Type			Storm Grate/Utility Type	
		N/A			N/A
			Yes	Surface Condition? (G/P)	Good

Remove & Replace Curb Ramp With Two New Directional Ramps or Equivalent.

Total Cost: \$ 3200.00
