# Access Compliance Report

## Public Rights-of-Way

### (Curb Ramps)

| Intersection ID: 8673 | Main Street: ROWAN_ST | Cross Street: TILLMAN_RD | Location: NE |

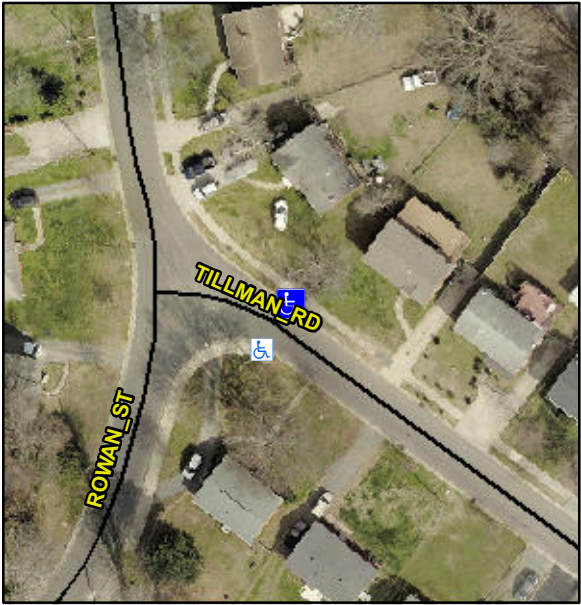
| ADA ID: 75E2459A3D0D | Ramp Type: Perp | Initial Pass/Fail: Fail | Overall Compliance: No |

| Codes/Mitigation Info/Possible Solution | | | Field Measurements/Component Compliance | | |
|---|---|--|---|---|---|
| <p>Surveyor Notes:</p> <p><b>N/A</b></p> <p>PROW/ADA:</p> <p><b>Not Found, R304.5.3</b></p> | | | <b>N/A</b> | Landing X Slope (%) | N/A |

| Codes/Mitigation Info/Possible Solution | | | Field Measurements/Component Compliance | | |
|---|---|--|---|---|---|
| | <b>Remove &amp; Replace Entire Ramp.</b> | | <b>Yes</b> | Ramp Length (in) | 47.5 |
| <p>Total Cost: \$ 1850.00</p> | | | <b>N/A</b> | Ramp inside XWalk1? | N/A |
