Access Compliance Report

Public Rights-of-Way

(Curb Ramps)

Intersection ID: 28429	Main Street: CHASTAIN_PARC_DR	Cross Street: LADY_ANN_CT	Location: SE
ADA ID: 75E255B02820	Ramp Type: Perp	Initial Pass/Fail: Fail	Overall Compliance: No
Severity Score: 8.75			
Codes/Mitigation Info/Possible Solution		Field Measurements/Component Compliance

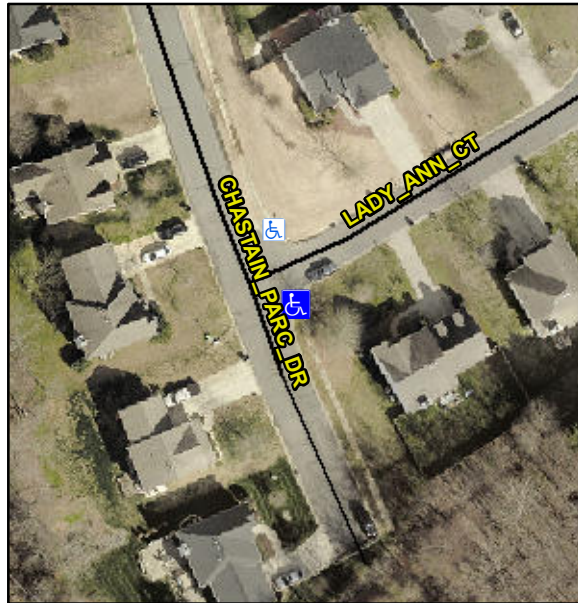
Not Found, R304.5.1

Compliance	Description	Data	Compliance	Description	Data
N/A	Ramp Length (in)	44.5	Yes	Ramp Slope (%)	6.2
No	Ramp Width (in)	38.5	Yes	Ramp XSlope (%)	0.2
N/A	Flare Type LT	N/A	N/A	Flare Type RT	N/A
N/A	Flare Slope LT (%)	N/A	N/A	Flare Slope RT (%)	N/A
N/A	Flare Traversable LT?	N/A	N/A	Flare Traversable RT?	N/A
N/A	Landing Length (in)	N/A	N/A	DWS Provided?	N/A
N/A	Landing Width (in)	N/A	N/A	DWS Contrast?	N/A
N/A	Landing Slope (%)	N/A	N/A	DWS Length (in)	N/A
N/A	Landing X Slope (%)	N/A	N/A	DWS Full Width?	N/A
N/A	Landing Curb? (Y/N)	N/A	N/A	DWS Offset (in)	N/A
N/A	Shared Landing?	N/A			
N/A	Gutter Ponding?	N/A	N/A	Gutter Slope (%)	N/A
N/A	Gutter Lip Ht (in)	N/A	N/A	Gutter X Slope (%)	N/A
N/A	Painted X Walk1?	No	N/A	Painted X Walk2?	N/A
	X Walk 1 Direction	To NE		X Walk 2 Direction	N/A
N/A	X Walk 1 Width (in)	N/A	N/A	X Walk 2 Width (in)	N/A
	X Walk 1 Slope (%)	5.7		X Walk 2 Slope (%)	N/A
	X Walk 1 X Slope (%)	1.0		X Walk 2 X Slope (%)	N/A

N/A	Ramp inside XWalk1?	N/A	N/A	Ramp inside XWalk2?	N/A
	Road Slope (%)	N/A	N/A	Clear Space?	N/A
	Road X Slope (%)	N/A	N/A	Clear Space to XWalk (in)	N/A
N/A	Any Obstructions?	N/A	N/A	Storm Grate/Utility Hazard?	N/A
	Obstruction Type			Storm Grate/Utility Type	
		N/A			N/A
			Yes	Surface Condition? (G/P)	Good

Possible Solutions:

Remove & Replace Entire Ramp.
