Access Compliance Report

Public Rights-of-Way

(Curb Ramps)

Intersection ID: 21469	Main Street: HOLLY_LN	Cross Street: SARDIS_RD	Location: SW
ADA ID: 75E2AB90AEE3	Ramp Type: PerpDiag	Initial Pass/Fail: Fail	Overall Compliance: No
Severity Score: 22.5			
Codes/Mitigation Info/Possible Solution		Field Measurements/Component Compliance

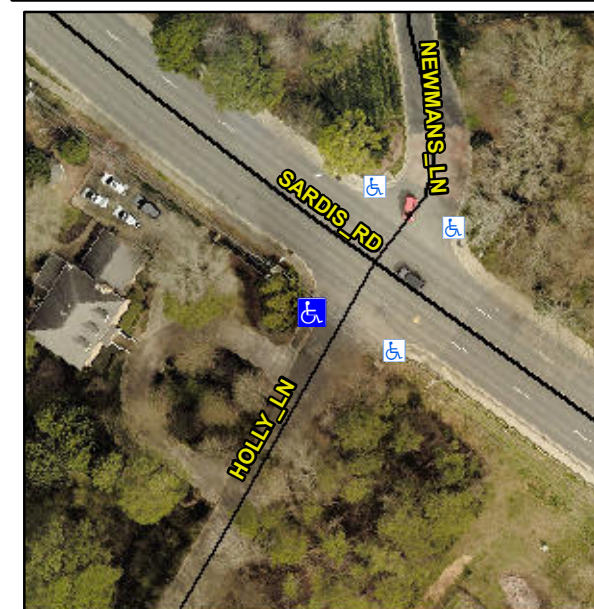
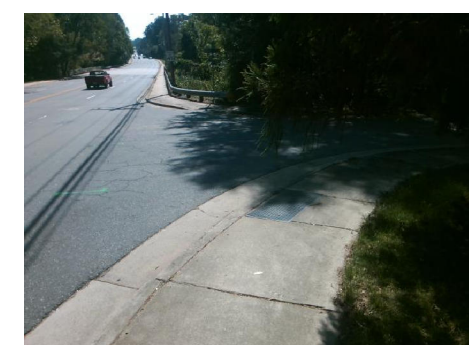
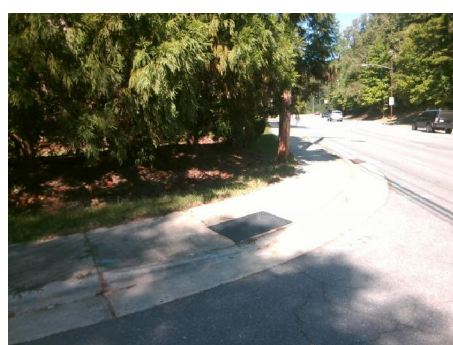
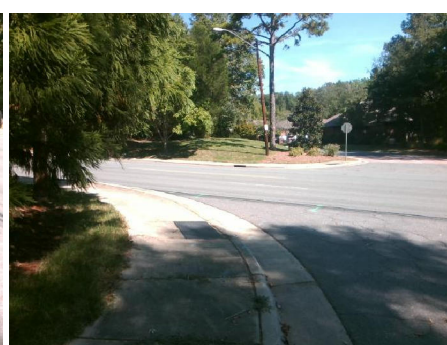
Not Found, R304.5.1, R304.2.2, R304.5.3

Compliance	Description	Data	Compliance	Description	Data
N/A	Ramp Length (in)	60.0	No	Ramp Slope (%)	9.4
No	Ramp Width (in)	39.0	No	Ramp XSlope (%)	3.8
N/A	Flare Type LT	N/A	N/A	Flare Type RT	N/A
N/A	Flare Slope LT (%)	N/A	N/A	Flare Slope RT (%)	N/A
N/A	Flare Traversable LT?	N/A	N/A	Flare Traversable RT?	N/A
N/A	Landing Length (in)	N/A	N/A	DWS Provided?	N/A
N/A	Landing Width (in)	N/A	N/A	DWS Contrast?	N/A
N/A	Landing Slope (%)	N/A	N/A	DWS Length (in)	N/A
N/A	Landing X Slope (%)	N/A	N/A	DWS Full Width?	N/A
N/A	Landing Curb? (Y/N)	N/A	N/A	DWS Offset (in)	N/A
N/A	Shared Landing?	N/A			
N/A	Gutter Ponding?	N/A	N/A	Gutter Slope (%)	N/A
N/A	Gutter Lip Ht (in)	1.0	N/A	Gutter X Slope (%)	N/A
N/A	Painted X Walk1?	No	N/A	Painted X Walk2?	No
	X Walk 1 Direction	To SE		X Walk 2 Direction	To NE
N/A	X Walk 1 Width (in)	N/A	N/A	X Walk 2 Width (in)	N/A
	X Walk 1 Slope (%)	4.9		X Walk 2 Slope (%)	1.7
	X Walk 1 X Slope (%)	4.4		X Walk 2 X Slope (%)	3.1

N/A	Ramp inside XWalk1?	N/A	N/A	Ramp inside XWalk2?	N/A
	Road Slope (%)	3.9	N/A	Clear Space?	N/A
	Road X Slope (%)	0.5	N/A	Clear Space to XWalk (in)	N/A
N/A	Any Obstructions?	N/A	N/A	Storm Grate/Utility Hazard?	N/A
	Obstruction Type			Storm Grate/Utility Type	
		N/A			N/A
			Yes	Surface Condition? (G/P)	Good

Remove & Replace Curb Ramp With Two New Directional Ramps or Equivalent.
