Intersection ID: 9237	Main Street: REDBUD_ST	Cross Street: BOOKER_AV	Location:	SW
ADA ID: 75E5C0110404	Ramp Type: PerpDiag	Initial Pass/Fail: Fail	Overall Compliance: No	Severity Score: 36.25

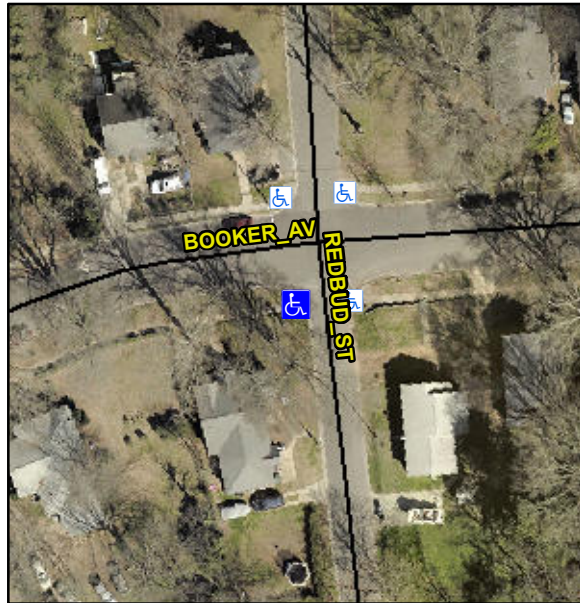
Not Found, R304.5.1, R304.5.3

Compliance	Description	Data	Compliance	Description	Data
N/A	Ramp Length (in)	58.5	Yes	Ramp Slope (%)	5.6
No	Ramp Width (in)	29.5	No	Ramp XSlope (%)	2.8
N/A	Flare Type LT	N/A	N/A	Flare Type RT	N/A
N/A	Flare Slope LT (%)	N/A	N/A	Flare Slope RT (%)	N/A
N/A	Flare Traversable LT?	N/A	N/A	Flare Traversable RT?	N/A
N/A	Landing Length (in)	N/A	N/A	DWS Provided?	N/A
N/A	Landing Width (in)	N/A	N/A	DWS Contrast?	N/A
N/A	Landing Slope (%)	N/A	N/A	DWS Length (in)	N/A
N/A	Landing X Slope (%)	N/A	N/A	DWS Full Width?	N/A
N/A	Landing Curb? (Y/N)	N/A	N/A	DWS Offset (in)	N/A
N/A	Shared Landing?	N/A			
N/A	Gutter Ponding?	N/A	N/A	Gutter Slope (%)	N/A
N/A	Gutter Lip Ht (in)	N/A	N/A	Gutter X Slope (%)	N/A
N/A	Painted X Walk1?	No	N/A	Painted X Walk2?	No
	X Walk 1 Direction	To E		X Walk 2 Direction	To N
N/A	X Walk 1 Width (in)	N/A	N/A	X Walk 2 Width (in)	N/A
	X Walk 1 Slope (%)	0.0		X Walk 2 Slope (%)	4.7
	X Walk 1 X Slope (%)	3.4		X Walk 2 X Slope (%)	1.6

N/A	Ramp inside XWalk1?	N/A	N/A	Ramp inside XWalk2?	N/A
	Road Slope (%)	2.4	N/A	Clear Space?	N/A
	Road X Slope (%)	0.7	N/A	Clear Space to XWalk (in)	N/A
N/A	Any Obstructions?	N/A	N/A	Storm Grate/Utility Hazard?	N/A
	Obstruction Type			Storm Grate/Utility Type	
		N/A			N/A
			Yes	Surface Condition? (G/P)	Good

Remove & Replace Curb Ramp With Two New Directional Ramps or Equivalent.
