Access Compliance Report

Public Rights-of-Way

(Curb Ramps)

Intersection ID: 5940	Main Street: UNIVERSITY_EXECUTIVE_PARK_DR	Cross Street: MCCULLOUGH_DR	Location: NE
ADA ID: 75EABED74304	Ramp Type: Perp	Initial Pass/Fail: Fail	Overall Compliance: No
Codes/Mitigation Info/Possible Solution		Field Measurements/Component Compliance	
Severity Score: 21.25

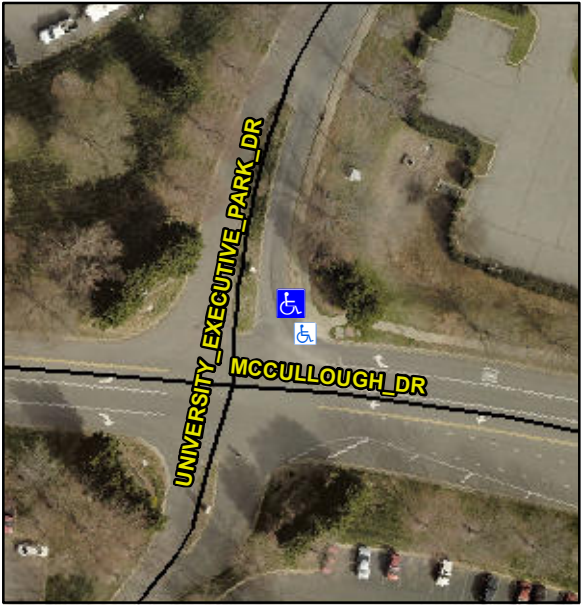
Possible Solutions:						
	Remove & Replace Entire Ramp.	N/A	Ramp Length (in)	63.0	No	Ramp Slope (%)	10.4
		No	Ramp Width (in)	43.0	Yes	Ramp XSlope (%)	1.6
		N/A	Flare Type LT	N/A	N/A	Flare Type RT	N/A
		N/A	Flare Slope LT (%)	N/A	N/A	Flare Slope RT (%)	N/A
		N/A	Flare Traversable LT?	N/A	N/A	Flare Traversable RT?	N/A
		N/A	Landing Length (in)	N/A	N/A	DWS Provided?	N/A
		N/A	Landing Width (in)	N/A	N/A	DWS Contrast?	N/A
		N/A	Landing Slope (%)	N/A	N/A	DWS Length (in)	N/A
		N/A	Landing X Slope (%)	N/A	N/A	DWS Full Width?	N/A
<p>Surveyor Notes:</p> <p>N/A</p> <p>PROW/ADA:</p> <p>Not Found, R304.5.1, R304.2.2</p>		N/A	Landing Curb? (Y/N)	N/A	N/A	DWS Offset (in)	N/A
		N/A	Shared Landing?	N/A			
		N/A	Gutter Ponding?	N/A	N/A	Gutter Slope (%)	N/A
		N/A	Gutter Lip Ht (in)	N/A	N/A	Gutter X Slope (%)	N/A
		N/A	Painted X Walk1?	No	N/A	Painted X Walk2?	N/A
			X Walk 1 Direction	To W		X Walk 2 Direction	N/A
		N/A	X Walk 1 Width (in)	N/A	N/A	X Walk 2 Width (in)	N/A

X Walk 1 Slope (%)	1.5		X Walk 2 Slope (%)	N/A
			X Walk 1 X Slope (%)	0.7		X Walk 2 X Slope (%)	N/A
		N/A	Ramp inside XWalk1?	N/A	N/A	Ramp inside XWalk2?	N/A
<p>Total Cost:</p> <p>\$ 1850.00</p>			Road Slope (%)	N/A	N/A	Clear Space?	N/A
			Road X Slope (%)	N/A	N/A	Clear Space to XWalk (in)	N/A
		N/A	Any Obstructions?	N/A	N/A	Storm Grate/Utility Hazard?	N/A
			Obstruction Type			Storm Grate/Utility Type	
					N/A		N/A
					Yes	Surface Condition? (G/P)	Good
