Access Compliance Report Public Rights-of-Way (Curb Ramps)

Intersection ID: 11522 Main Street: AVENSONG_CROSSING_DR Cross Street: HARPLEY_CT Location: NW
ADA ID: 75F2203FB59D Ramp Type: Combination2 Initial Pass/Fail: Fail Overall Compliance: No Severity Score: 21.25

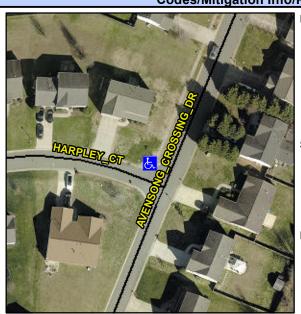
Possible Solutions:
Remove & Replace Entire Ramp.
•
Surveyor Notes:
GTR GAP 4.0, LT RP < 5%
PROW/ADA:
Not Found, R304.5.1, R304.5.1,
R304.5.3
