# Access Compliance Report

## Public Rights-of-Way

### (Curb Ramps)

Intersection ID: 10026441	Main Street: FARMHURST_DR	Cross Street: N/A	Location: SW
ADA ID: 75F274918DB0	Ramp Type: PerpDiag	Initial Pass/Fail: Fail	Overall Compliance: No
Severity Score: 37.5			
Codes/Mitigation Info/Possible Solution		Field Measurements/Component Compliance

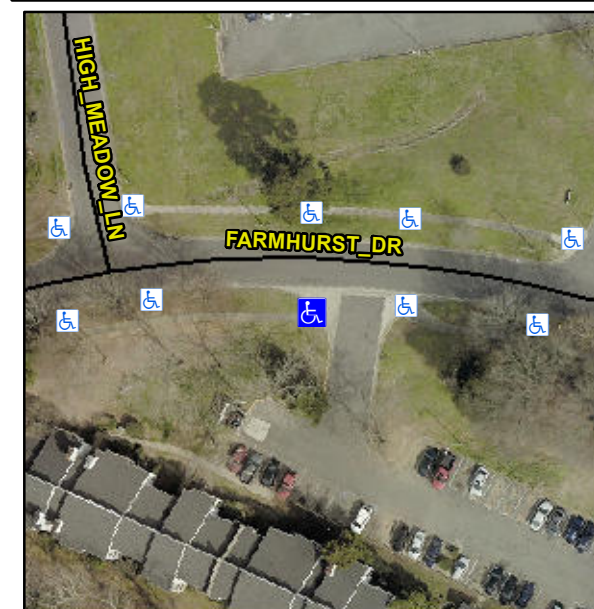
**Not Found, R304.2.2, R304.5.3**

Compliance	Description	Data	Compliance	Description	Data
N/A	Ramp Length (in)	48.0	No	Ramp Slope (%)	8.6
Yes	Ramp Width (in)	48.0	No	Ramp XSlope (%)	14.4
N/A	Flare Type LT	N/A	N/A	Flare Type RT	N/A
N/A	Flare Slope LT (%)	N/A	N/A	Flare Slope RT (%)	N/A
N/A	Flare Traversable LT?	N/A	N/A	Flare Traversable RT?	N/A
N/A	Landing Length (in)	N/A	N/A	DWS Provided?	N/A
N/A	Landing Width (in)	N/A	N/A	DWS Contrast?	N/A
N/A	Landing Slope (%)	N/A	N/A	DWS Length (in)	N/A
N/A	Landing X Slope (%)	N/A	N/A	DWS Full Width?	N/A
N/A	Landing Curb? (Y/N)	N/A	N/A	DWS Offset (in)	N/A
N/A	Shared Landing?	N/A			
N/A	Gutter Ponding?	N/A	N/A	Gutter Slope (%)	N/A
N/A	Gutter Lip Ht (in)	N/A	N/A	Gutter X Slope (%)	N/A
N/A	Painted X Walk1?	No	N/A	Painted X Walk2?	No
	X Walk 1 Direction	To E		X Walk 2 Direction	To N
N/A	X Walk 1 Width (in)	N/A	N/A	X Walk 2 Width (in)	N/A
	X Walk 1 Slope (%)	5.2		X Walk 2 Slope (%)	10.0
	X Walk 1 X Slope (%)	11.1		X Walk 2 X Slope (%)	0.3

N/A	Ramp inside XWalk1?	N/A	N/A	Ramp inside XWalk2?	N/A
	Road Slope (%)	8.9	N/A	Clear Space?	N/A
	Road X Slope (%)	8.1	N/A	Clear Space to XWalk (in)	N/A
N/A	Any Obstructions?	N/A	N/A	Storm Grate/Utility Hazard?	N/A
	Obstruction Type			Storm Grate/Utility Type	
		N/A			N/A
		Yes		Surface Condition? (G/P)	Good

Possible Solutions:

**Remove & Replace Curb Ramp With Two New Directional Ramps or Equivalent.**

Total Cost: \$ 3200.00
