Access Compliance Report

Public Rights-of-Way

(Curb Ramps)

Intersection ID: 43676	Main Street: SARDIS_COMMONS_LN	Cross Street: SARDIS_RD	Location: SW
ADA ID: 75F43041F433	Ramp Type: PerpDiag	Initial Pass/Fail: Fail	Overall Compliance: No
Severity Score: 33.75			
Codes/Mitigation Info/Possible Solution		Field Measurements/Component Compliance

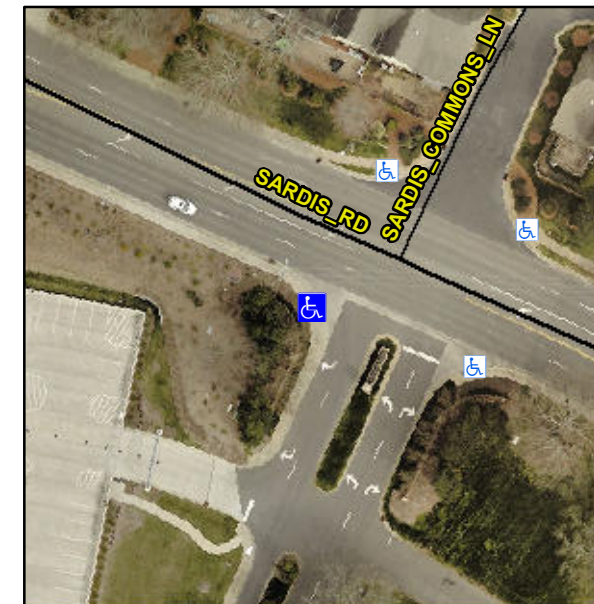
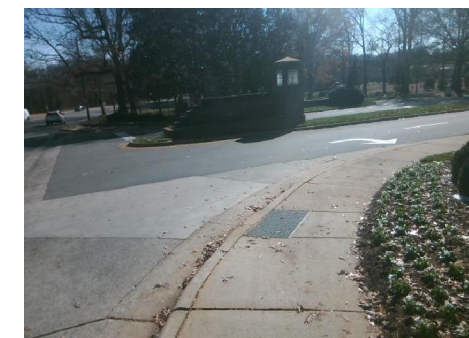
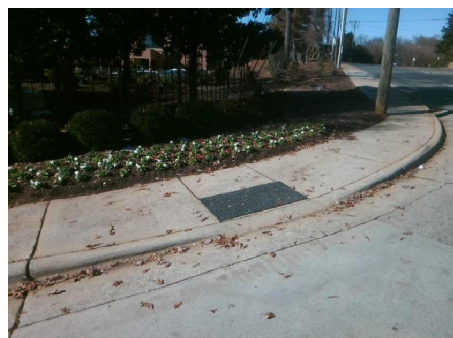
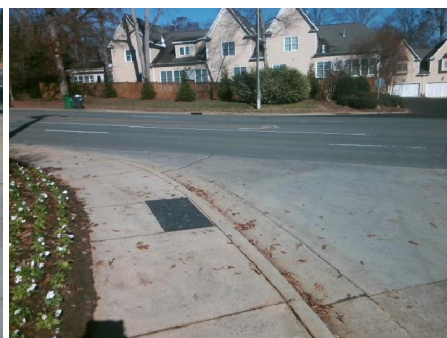
Not Found, R304.5.1, R304.5.3

Compliance	Description	Data	Compliance	Description	Data
N/A	Ramp Length (in)	60.0	Yes	Ramp Slope (%)	7.3
No	Ramp Width (in)	43.0	No	Ramp XSlope (%)	8.8
N/A	Flare Type LT	N/A	N/A	Flare Type RT	N/A
N/A	Flare Slope LT (%)	N/A	N/A	Flare Slope RT (%)	N/A
N/A	Flare Traversable LT?	N/A	N/A	Flare Traversable RT?	N/A
N/A	Landing Length (in)	N/A	N/A	DWS Provided?	N/A
N/A	Landing Width (in)	N/A	N/A	DWS Contrast?	N/A
N/A	Landing Slope (%)	N/A	N/A	DWS Length (in)	N/A
N/A	Landing X Slope (%)	N/A	N/A	DWS Full Width?	N/A
N/A	Landing Curb? (Y/N)	N/A	N/A	DWS Offset (in)	N/A
N/A	Shared Landing?	N/A			
N/A	Gutter Ponding?	N/A	N/A	Gutter Slope (%)	N/A
N/A	Gutter Lip Ht (in)	N/A	N/A	Gutter X Slope (%)	N/A
N/A	Painted X Walk1?	No	N/A	Painted X Walk2?	No
	X Walk 1 Direction	To SE		X Walk 2 Direction	To NE
N/A	X Walk 1 Width (in)	N/A	N/A	X Walk 2 Width (in)	N/A
	X Walk 1 Slope (%)	5.6		X Walk 2 Slope (%)	3.4
	X Walk 1 X Slope (%)	4.5		X Walk 2 X Slope (%)	7.2

N/A	Ramp inside XWalk1?	N/A	N/A	Ramp inside XWalk2?	N/A
	Road Slope (%)	7.4	N/A	Clear Space?	N/A
	Road X Slope (%)	2.7	N/A	Clear Space to XWalk (in)	N/A
N/A	Any Obstructions?	N/A	N/A	Storm Grate/Utility Hazard?	N/A
	Obstruction Type			Storm Grate/Utility Type	
		N/A			N/A
			Yes	Surface Condition? (G/P)	Good

Remove & Replace Curb Ramp With Two New Directional Ramps or Equivalent.
