# Access Compliance Report

## Public Rights-of-Way

### (Curb Ramps)

Intersection ID: 27355	Main Street: JOHNSTON_RD	Cross Street: BRIXHAM_HILL_AV	Location: SE
ADA ID: 75F795BB13AD	Ramp Type: BlendTrans2	Initial Pass/Fail: Fail	Overall Compliance: No
Severity Score: 8.75			
Codes/Mitigation Info/Possible Solution		Field Measurements/Component Compliance

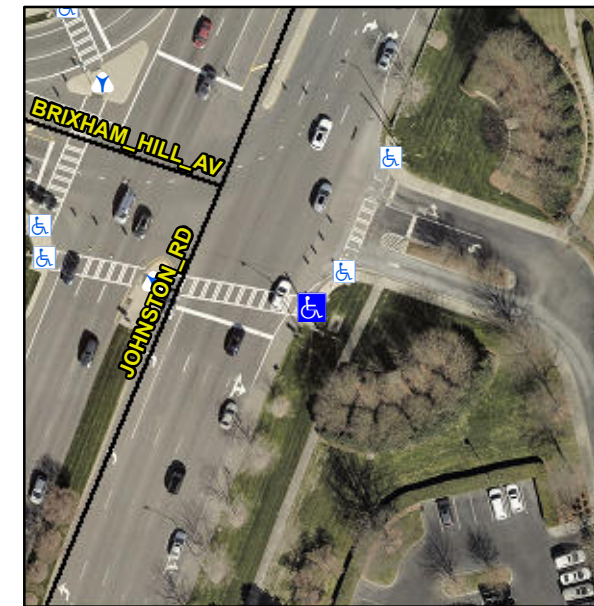
**Not Found, R304.5.1**

Compliance	Description	Data	Compliance	Description	Data
N/A	Ramp Length (in)	59.0	Yes	BlendTrans Slope (%)	1.9
No	Ramp Width (in)	46.0	Yes	BlendTrans XSlope (%)	1.1
N/A	Flare Type LT	N/A	N/A	Flare Type RT	N/A
N/A	Flare Slope LT (%)	N/A	N/A	Flare Slope RT (%)	N/A
N/A	Flare Traversable LT?	N/A	N/A	Flare Traversable RT?	N/A
N/A	Landing Length (in)	N/A	N/A	DWS Provided?	N/A
N/A	Landing Width (in)	N/A	N/A	DWS Contrast?	N/A
N/A	Landing Slope (%)	N/A	N/A	DWS Length (in)	N/A
N/A	Landing X Slope (%)	N/A	N/A	DWS Full Width?	N/A
N/A	Landing Curb? (Y/N)	N/A	N/A	DWS Offset (in)	N/A
N/A	Shared Landing?	N/A			
N/A	Gutter Ponding?	N/A	N/A	Gutter Slope (%)	N/A
N/A	Gutter Lip Ht (in)	N/A	N/A	Gutter X Slope (%)	N/A
N/A	Painted X Walk1?	Yes	N/A	Painted X Walk2?	N/A
	X Walk 1 Direction	To W		X Walk 2 Direction	N/A
	X Walk 1 Width (in)	112.0		X Walk 2 Width (in)	N/A
	X Walk 1 Slope (%)	6.0		X Walk 2 Slope (%)	N/A
	X Walk 1 X Slope (%)	1.8		X Walk 2 X Slope (%)	N/A

N/A	Ramp inside XWalk1?	Yes	N/A	Ramp inside XWalk2?	N/A
	Road Slope (%)	1.8		Clear Space?	N/A
	Road X Slope (%)	6.0	N/A	Clear Space to XWalk (in)	N/A
N/A	Any Obstructions?	N/A	N/A	Storm Grate/Utility Hazard?	N/A
	Obstruction Type			Storm Grate/Utility Type	
		N/A			N/A
			Yes	Surface Condition? (G/P)	Good
			No	Curb Slope (%)	23.4

**Remove & Replace Curb Ramp With Two New Directional Ramps or Equivalent.**

Total Cost: \$ 3200.00
