# Access Compliance Report

## Public Rights-of-Way

### (Curb Ramps)

Intersection ID: 42790	Main Street: CALDWELL_CROSSING_PY	Cross Street: ERWIN_RIDGE_AV	Location: SW
ADA ID: 75FCF7A04294	Ramp Type: PerpDiag	Initial Pass/Fail: Fail	Overall Compliance: No
			Severity Score: 21.25

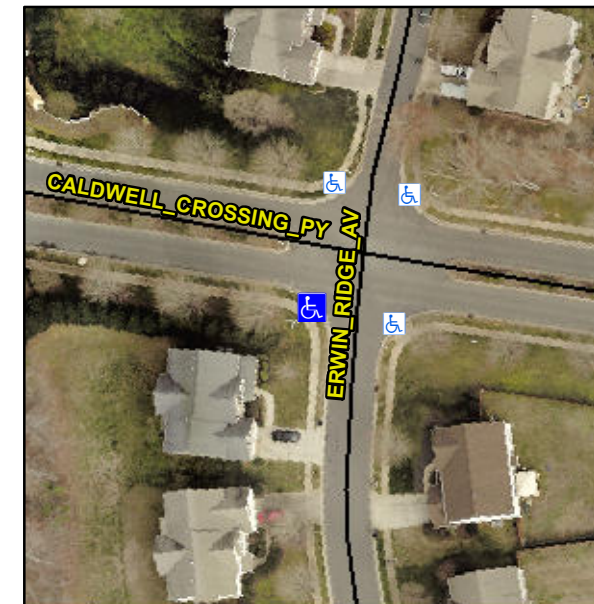
**Not Found, R304.5.1, R304.2.2**

Compliance	Description	Data	Compliance	Description	Data
N/A	Ramp Length (in)	49.0	No	Ramp Slope (%)	9.4
No	Ramp Width (in)	37.5	Yes	Ramp XSlope (%)	0.8
N/A	Flare Type LT	N/A	N/A	Flare Type RT	N/A
N/A	Flare Slope LT (%)	N/A	N/A	Flare Slope RT (%)	N/A
N/A	Flare Traversable LT?	N/A	N/A	Flare Traversable RT?	N/A
N/A	Landing Length (in)	N/A	N/A	DWS Provided?	N/A
N/A	Landing Width (in)	N/A	N/A	DWS Contrast?	N/A
N/A	Landing Slope (%)	N/A	N/A	DWS Length (in)	N/A
N/A	Landing X Slope (%)	N/A	N/A	DWS Full Width?	N/A
N/A	Landing Curb? (Y/N)	N/A	N/A	DWS Offset (in)	N/A
N/A	Shared Landing?	N/A			
N/A	Gutter Ponding?	N/A	N/A	Gutter Slope (%)	N/A
N/A	Gutter Lip Ht (in)	N/A	N/A	Gutter X Slope (%)	N/A
N/A	Painted X Walk1?	No	N/A	Painted X Walk2?	No
	X Walk 1 Direction	To SE		X Walk 2 Direction	To NW
N/A	X Walk 1 Width (in)	N/A	N/A	X Walk 2 Width (in)	N/A
	X Walk 1 Slope (%)	2.9		X Walk 2 Slope (%)	2.5
	X Walk 1 X Slope (%)	0.6		X Walk 2 X Slope (%)	4.2

N/A	Ramp inside XWalk1?	N/A	N/A	Ramp inside XWalk2?	N/A
	Road Slope (%)	0.0	N/A	Clear Space?	N/A
	Road X Slope (%)	4.1	N/A	Clear Space to XWalk (in)	N/A
N/A	Any Obstructions?	N/A	N/A	Storm Grate/Utility Hazard?	N/A
	Obstruction Type			Storm Grate/Utility Type	
		N/A			N/A
			Yes	Surface Condition? (G/P)	Good

**Remove & Replace Curb Ramp With Two New Directional Ramps or Equivalent.**
