# Access Compliance Report

### (Curb Ramps)

| Intersection ID: 27921 | Main Street: BLAKENEY_HEATH_RD | Cross Street: CHARNWOOD_CT | Location: E |
| ADA ID: 75FD17CEBA56 | Ramp Type: PerpDiag | Initial Pass/Fail: Fail | Overall Compliance: No |

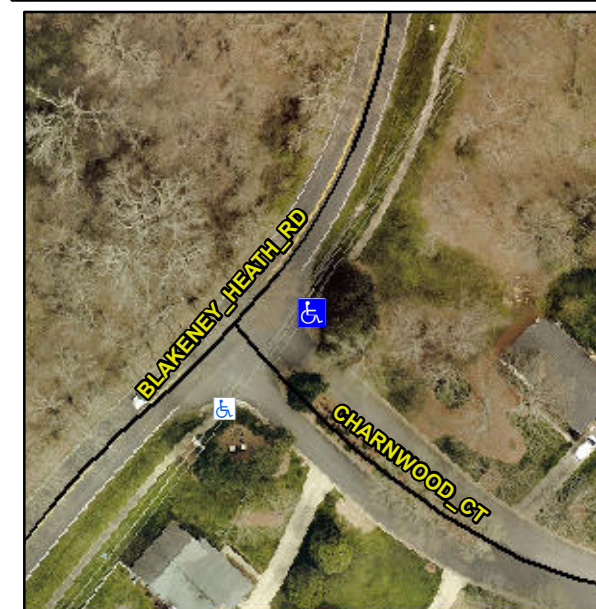
| Severity Score: 37.5 | | | |

**R304.2.2, R304.5.3**

| Compliance | Description | Data | Compliance | Description | Data |
|---|---|---|---|---|---|
| N/A | Ramp Length (in) | 65.0 | No | Ramp Slope (%) | 12.2 |
| Yes | Ramp Width (in) | 48.0 | No | Ramp XSlope (%) | 5.9 |

**Remove & Replace Curb Ramp With Two New Directional Ramps or Equivalent.**

Total Cost: \$ 3200.00
