Access Compliance Report

Public Rights-of-Way

(Curb Ramps)

Intersection ID: 20241	Main Street: ANN_MARIE_DR	Cross Street: NATIONS_FORD_RD	Location: SW
ADA ID: 75FD48F10755	Ramp Type: BlendTrans2	Initial Pass/Fail: Fail	Overall Compliance: No
Severity Score: 10			
Codes/Mitigation Info/Possible Solution		Field Measurements/Component Compliance

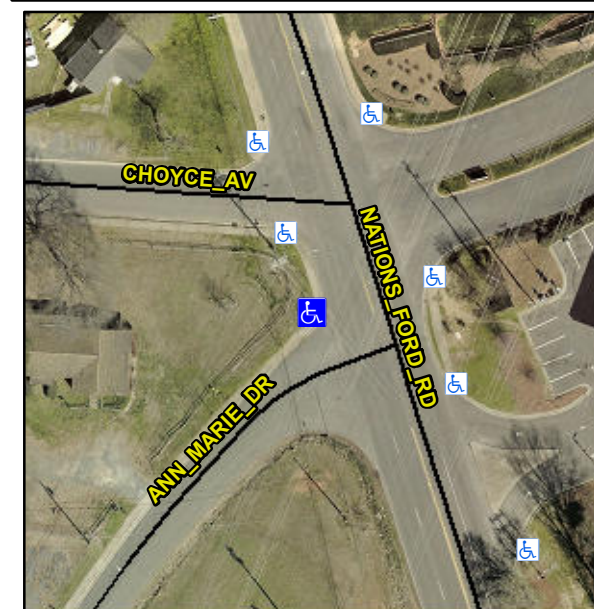
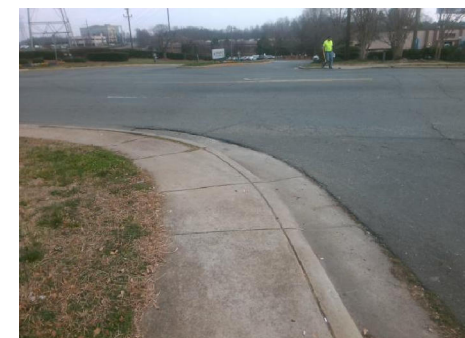
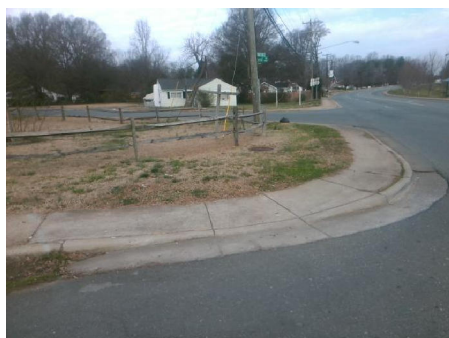
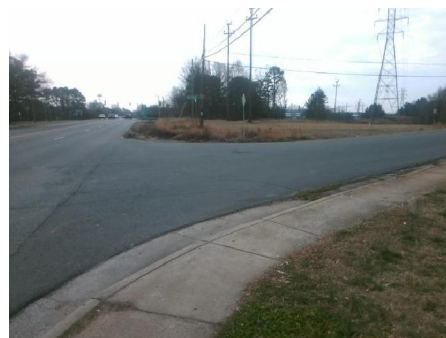
Not Found, R304.5.1, R304.5.3

Compliance	Description	Data	Compliance	Description	Data
N/A	Ramp Length (in)	48.0	Yes	BlendTrans Slope (%)	2.6
No	Ramp Width (in)	38.0	No	BlendTrans XSlope (%)	2.5
N/A	Flare Type LT	N/A	N/A	Flare Type RT	N/A
N/A	Flare Slope LT (%)	N/A	N/A	Flare Slope RT (%)	N/A
N/A	Flare Traversable LT?	N/A	N/A	Flare Traversable RT?	N/A
N/A	Landing Length (in)	N/A	N/A	DWS Provided?	N/A
N/A	Landing Width (in)	N/A	N/A	DWS Contrast?	N/A
N/A	Landing Slope (%)	N/A	N/A	DWS Length (in)	N/A
N/A	Landing X Slope (%)	N/A	N/A	DWS Full Width?	N/A
N/A	Landing Curb? (Y/N)	N/A	N/A	DWS Offset (in)	N/A
N/A	Shared Landing?	N/A			
N/A	Gutter Ponding?	N/A	N/A	Gutter Slope (%)	N/A
N/A	Gutter Lip Ht (in)	N/A	N/A	Gutter X Slope (%)	N/A
N/A	Painted X Walk1?	No	N/A	Painted X Walk2?	No
	X Walk 1 Direction	To S		X Walk 2 Direction	To E
	X Walk 1 Width (in)	N/A		X Walk 2 Width (in)	N/A
	X Walk 1 Slope (%)	4.5		X Walk 2 Slope (%)	2.0
	X Walk 1 X Slope (%)	1.1		X Walk 2 X Slope (%)	3.9

N/A	Ramp inside XWalk1?	N/A	N/A	Ramp inside XWalk2?	N/A
	Road Slope (%)	1.2		Clear Space?	N/A
	Road X Slope (%)	6.9	N/A	Clear Space to XWalk (in)	N/A
N/A	Any Obstructions?	N/A	N/A	Storm Grate/Utility Hazard?	N/A
	Obstruction Type			Storm Grate/Utility Type	
		N/A			N/A
			Yes	Surface Condition? (G/P)	Good
			No	Curb Slope (%)	5.5

Remove & Replace Curb Ramp With Two New Directional Ramps or Equivalent.
