# Access Compliance Report

## Public Rights-of-Way

### (Curb Ramps)

Intersection ID: 53326	Main Street: FLINT_HILL_DR	Cross Street: CALAWOOD_WY	Location: NW
ADA ID: 75FFD47F1913	Ramp Type: BlendTrans1	Initial Pass/Fail: Fail	Overall Compliance: No
		Severity Score: 8.75

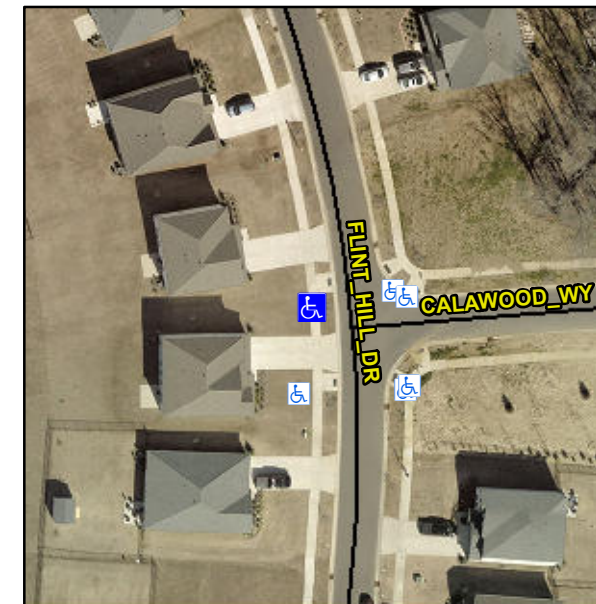
Compliance	Description	Data	Compliance	Description	Data
N/A	Ramp Length (in)	96.0	Yes	BlendTrans Slope (%)	4.3
No	Ramp Width (in)	46.5	Yes	BlendTrans XSlope (%)	0.6
N/A	Flare Type LT	N/A	N/A	Flare Type RT	N/A
N/A	Flare Slope LT (%)	N/A	N/A	Flare Slope RT (%)	N/A
N/A	Flare Traversable LT?	N/A	N/A	Flare Traversable RT?	N/A
N/A	Landing Length (in)	N/A	N/A	DWS Provided?	N/A
N/A	Landing Width (in)	N/A	N/A	DWS Contrast?	N/A
N/A	Landing Slope (%)	N/A	N/A	DWS Length (in)	N/A
N/A	Landing X Slope (%)	N/A	N/A	DWS Full Width?	N/A
N/A	Landing Curb? (Y/N)	N/A	N/A	DWS Offset (in)	N/A
N/A	Shared Landing?	N/A			
N/A	Gutter Ponding?	N/A	N/A	Gutter Slope (%)	N/A
N/A	Gutter Lip Ht (in)	0.5	N/A	Gutter X Slope (%)	N/A
N/A	Painted X Walk1?	No	N/A	Painted X Walk2?	N/A
	X Walk 1 Direction	To E		X Walk 2 Direction	N/A
	X Walk 1 Width (in)	N/A		X Walk 2 Width (in)	N/A
	X Walk 1 Slope (%)	2.3		X Walk 2 Slope (%)	N/A
	X Walk 1 X Slope (%)	1.2		X Walk 2 X Slope (%)	N/A

N/A	Ramp inside XWalk1?	N/A	N/A	Ramp inside XWalk2?	N/A
	Road Slope (%)	1.2		Clear Space?	N/A
	Road X Slope (%)	2.3	N/A	Clear Space to XWalk (in)	N/A
N/A	Any Obstructions?	N/A	N/A	Storm Grate/Utility Hazard?	N/A
	Obstruction Type			Storm Grate/Utility Type	
		N/A			N/A
			Yes	Surface Condition? (G/P)	Good
			N/A	Curb Slope (%)	3.5

**Remove & Replace Curb Ramp With Two New Directional Ramps or Equivalent.**

**R304.5.1**
