Access Compliance Report

Public Rights-of-Way

(Curb Ramps)

Intersection ID: 5837	Main Street: BLACK WALNUT LN	Cross Street: PEPPERBUSH CT	Location:	N
ADA ID: 760DD0AA1152	Ramp Type: Perp	Initial Pass/Fail: Fail	Overall Compliance: No	Severity Score: 8.75

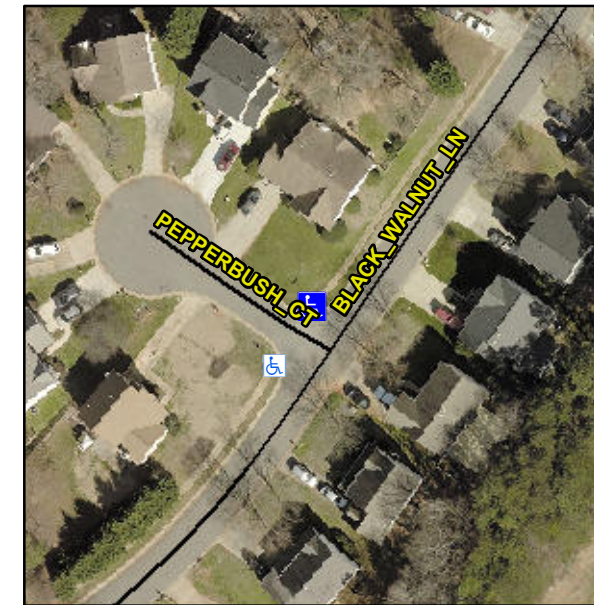
Not Found, R304.5.1

Compliance	Description	Data	Compliance	Description	Data
N/A	Ramp Length (in)	94.0	Yes	Ramp Slope (%)	6.8
No	Ramp Width (in)	47.0	Yes	Ramp XSlope (%)	1.7
N/A	Flare Type LT	N/A	N/A	Flare Type RT	N/A
N/A	Flare Slope LT (%)	N/A	N/A	Flare Slope RT (%)	N/A
N/A	Flare Traversable LT?	N/A	N/A	Flare Traversable RT?	N/A
N/A	Landing Length (in)	N/A	N/A	DWS Provided?	N/A
N/A	Landing Width (in)	N/A	N/A	DWS Contrast?	N/A
N/A	Landing Slope (%)	N/A	N/A	DWS Length (in)	N/A
N/A	Landing X Slope (%)	N/A	N/A	DWS Full Width?	N/A
N/A	Landing Curb? (Y/N)	N/A	N/A	DWS Offset (in)	N/A
N/A	Shared Landing?	N/A			
N/A	Gutter Ponding?	N/A	N/A	Gutter Slope (%)	N/A
N/A	Gutter Lip Ht (in)	N/A	N/A	Gutter X Slope (%)	N/A
N/A	Painted X Walk1?	No	N/A	Painted X Walk2?	N/A
	X Walk 1 Direction	To SW		X Walk 2 Direction	N/A
N/A	X Walk 1 Width (in)	N/A	N/A	X Walk 2 Width (in)	N/A
	X Walk 1 Slope (%)	2.8		X Walk 2 Slope (%)	N/A
	X Walk 1 X Slope (%)	2.5		X Walk 2 X Slope (%)	N/A

Remove & Replace Entire Ramp.

Total Cost: \$ 1850.00
