Access Compliance Report

Public Rights-of-Way

(Curb Ramps)

Intersection ID: 46805	Main Street: ARBOR_CREST_CT	Cross Street: RED_BIRCH_DR	Location: W
ADA ID: 7612E26B7895	Ramp Type: PerpDiag	Initial Pass/Fail: Fail	Overall Compliance: No
Severity Score: 21.25			
Codes/Mitigation Info/Possible Solution		Field Measurements/Component Compliance

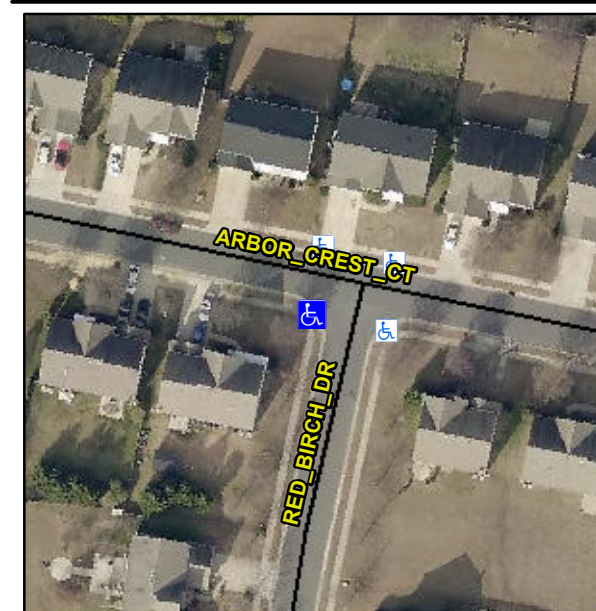
Not Found, R304.5.1, R304.5.3

Compliance	Description	Data	Compliance	Description	Data
N/A	Ramp Length (in)	49.0	Yes	Ramp Slope (%)	5.9
No	Ramp Width (in)	40.0	No	Ramp XSlope (%)	5.3
N/A	Flare Type LT	N/A	N/A	Flare Type RT	N/A
N/A	Flare Slope LT (%)	N/A	N/A	Flare Slope RT (%)	N/A
N/A	Flare Traversable LT?	N/A	N/A	Flare Traversable RT?	N/A
N/A	Landing Length (in)	N/A	N/A	DWS Provided?	N/A
N/A	Landing Width (in)	N/A	N/A	DWS Contrast?	N/A
N/A	Landing Slope (%)	N/A	N/A	DWS Length (in)	N/A
N/A	Landing X Slope (%)	N/A	N/A	DWS Full Width?	N/A
N/A	Landing Curb? (Y/N)	N/A	N/A	DWS Offset (in)	N/A
N/A	Shared Landing?	N/A			
N/A	Gutter Ponding?	N/A	N/A	Gutter Slope (%)	N/A
N/A	Gutter Lip Ht (in)	N/A	N/A	Gutter X Slope (%)	N/A
N/A	Painted X Walk1?	No	N/A	Painted X Walk2?	No
	X Walk 1 Direction	To SE		X Walk 2 Direction	To NE
N/A	X Walk 1 Width (in)	N/A	N/A	X Walk 2 Width (in)	N/A
	X Walk 1 Slope (%)	0.4		X Walk 2 Slope (%)	4.4
	X Walk 1 X Slope (%)	4.5		X Walk 2 X Slope (%)	1.2

N/A	Ramp inside XWalk1?	N/A	N/A	Ramp inside XWalk2?	N/A
	Road Slope (%)	4.2	N/A	Clear Space?	N/A
	Road X Slope (%)	2.4	N/A	Clear Space to XWalk (in)	N/A
N/A	Any Obstructions?	N/A	N/A	Storm Grate/Utility Hazard?	N/A
	Obstruction Type			Storm Grate/Utility Type	
		N/A			N/A
			Yes	Surface Condition? (G/P)	Good

Possible Solutions:

Remove & Replace Curb Ramp With Two New Directional Ramps or Equivalent.
