# Access Compliance Report

## Public Rights-of-Way

### (Curb Ramps)

| Intersection ID: 10020719 | Main Street: BEATTIES_FORD_RD | Cross Street: N/A | Location: W |

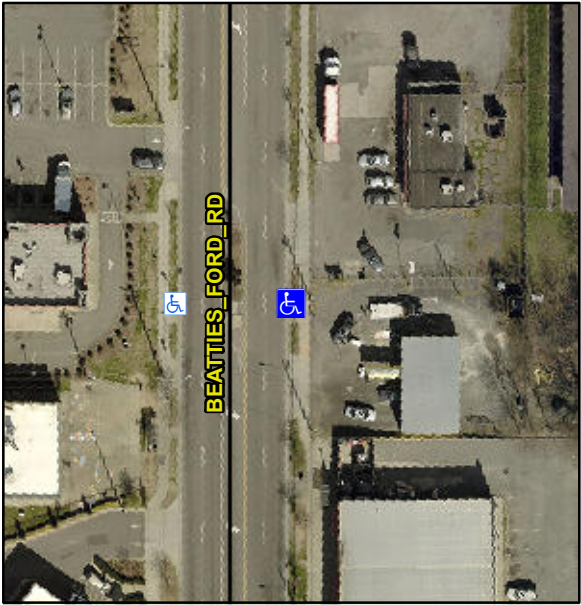
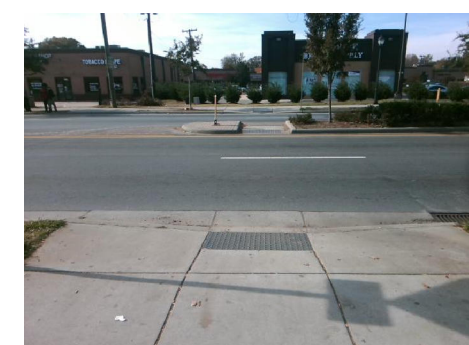
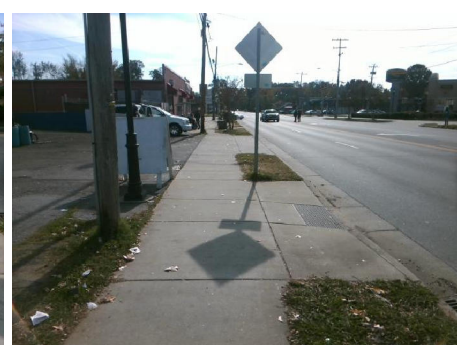
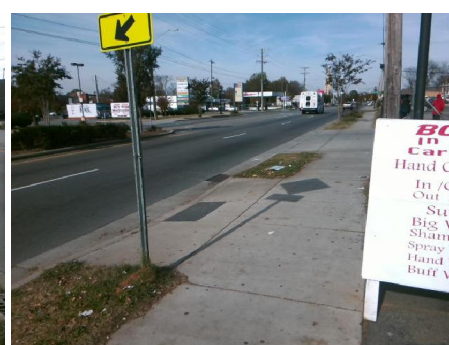
| ADA ID: 76170E17A0BE | Ramp Type: Perp | Initial Pass/Fail: Fail | Overall Compliance: No |

| | Remove & Replace Entire Ramp. | N/A | Ramp Length (in) | 48.0 | No | Ramp Slope (%) | 10.8 |
| <p>Surveyor Notes:</p> <p>N/A</p> <p>PROW/ADA:</p> <p>R304.2.2</p> | | N/A | Landing Curb? (Y/N) | N/A | N/A | DWS Offset (in) | N/A |

| Total Cost: | | \$ | 1850.00 | | | | |
