Access Compliance Report

Public Rights-of-Way

(Curb Ramps)

Intersection ID: 15957	Main Street: MARYLAND_AV	Cross Street: STERLING_RD	Location: SW
ADA ID: 7617EF62A666	Ramp Type: PerpDiag	Initial Pass/Fail: Fail	Overall Compliance: No
Severity Score: 12.5			
Codes/Mitigation Info/Possible Solution		Field Measurements/Component Compliance

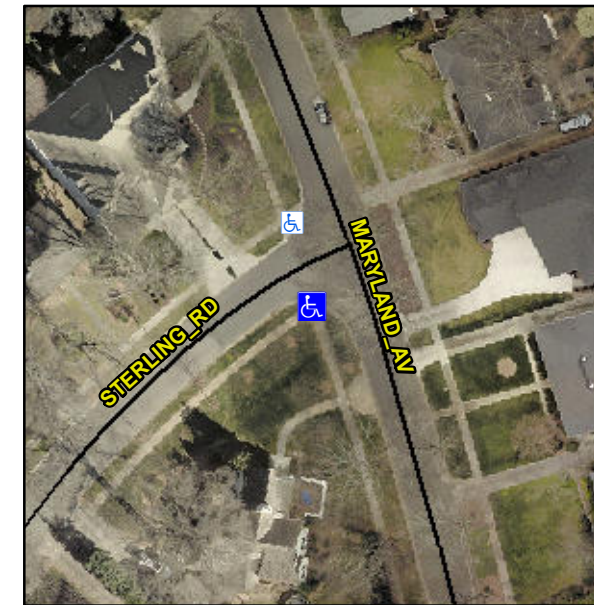
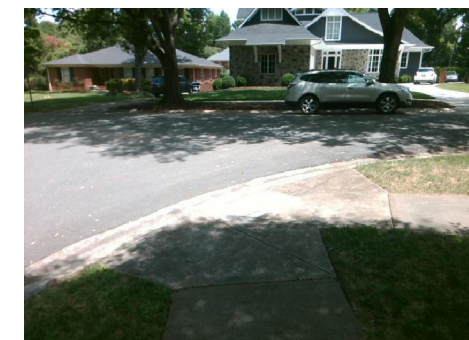
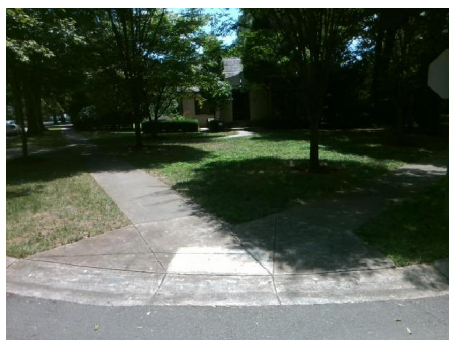
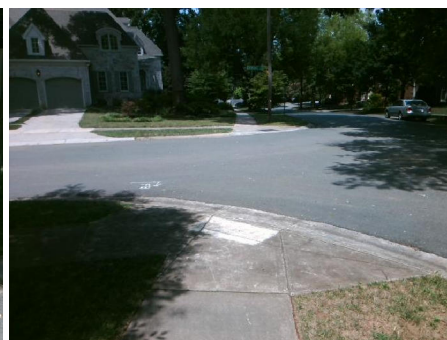
Not Found, R304.2.2

Compliance	Description	Data	Compliance	Description	Data
N/A	Ramp Length (in)	70.0	No	Ramp Slope (%)	8.5
Yes	Ramp Width (in)	48.0	Yes	Ramp XSlope (%)	0.7
N/A	Flare Type LT	N/A	N/A	Flare Type RT	N/A
N/A	Flare Slope LT (%)	N/A	N/A	Flare Slope RT (%)	N/A
N/A	Flare Traversable LT?	N/A	N/A	Flare Traversable RT?	N/A
N/A	Landing Length (in)	N/A	N/A	DWS Provided?	N/A
N/A	Landing Width (in)	N/A	N/A	DWS Contrast?	N/A
N/A	Landing Slope (%)	N/A	N/A	DWS Length (in)	N/A
N/A	Landing X Slope (%)	N/A	N/A	DWS Full Width?	N/A
N/A	Landing Curb? (Y/N)	N/A	N/A	DWS Offset (in)	N/A
N/A	Shared Landing?	N/A			
N/A	Gutter Ponding?	N/A	N/A	Gutter Slope (%)	N/A
N/A	Gutter Lip Ht (in)	N/A	N/A	Gutter X Slope (%)	N/A
N/A	Painted X Walk1?	No	N/A	Painted X Walk2?	No
	X Walk 1 Direction	To E		X Walk 2 Direction	To N
N/A	X Walk 1 Width (in)	N/A	N/A	X Walk 2 Width (in)	N/A
	X Walk 1 Slope (%)	3.0		X Walk 2 Slope (%)	1.3
	X Walk 1 X Slope (%)	2.8		X Walk 2 X Slope (%)	2.7

N/A	Ramp inside XWalk1?	N/A	N/A	Ramp inside XWalk2?	N/A
	Road Slope (%)	2.2	N/A	Clear Space?	N/A
	Road X Slope (%)	1.3	N/A	Clear Space to XWalk (in)	N/A
N/A	Any Obstructions?	N/A	N/A	Storm Grate/Utility Hazard?	N/A
	Obstruction Type			Storm Grate/Utility Type	
		N/A			N/A
		Yes		Surface Condition? (G/P)	Good

Remove & Replace Curb Ramp With Two New Directional Ramps or Equivalent.
