# Access Compliance Report

## Public Rights-of-Way

### (Curb Ramps)

Intersection ID: 18726	Main Street: TYVOLA_RD	Cross Street: OLD_PINEVILLE_RD	Location: SE
ADA ID: 76225272C627	Ramp Type: Perp	Initial Pass/Fail: Fail	Overall Compliance: No
Severity Score: 12.5			
Codes/Mitigation Info/Possible Solution		Field Measurements/Component Compliance

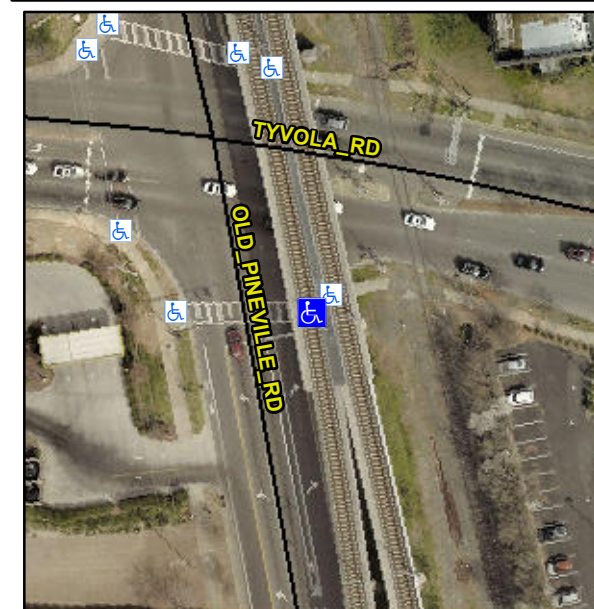
**Not Found, R304.2.2**

Compliance	Description	Data	Compliance	Description	Data
N/A	Ramp Length (in)	100.0	No	Ramp Slope (%)	8.7
Yes	Ramp Width (in)	48.0	Yes	Ramp XSlope (%)	1.6
N/A	Flare Type LT	N/A	N/A	Flare Type RT	N/A
N/A	Flare Slope LT (%)	N/A	N/A	Flare Slope RT (%)	N/A
N/A	Flare Traversable LT?	N/A	N/A	Flare Traversable RT?	N/A
N/A	Landing Length (in)	N/A	N/A	DWS Provided?	N/A
N/A	Landing Width (in)	N/A	N/A	DWS Contrast?	N/A
N/A	Landing Slope (%)	N/A	N/A	DWS Length (in)	N/A
N/A	Landing X Slope (%)	N/A	N/A	DWS Full Width?	N/A
N/A	Landing Curb? (Y/N)	N/A	N/A	DWS Offset (in)	N/A
N/A	Shared Landing?	N/A			
N/A	Gutter Ponding?	N/A	N/A	Gutter Slope (%)	N/A
N/A	Gutter Lip Ht (in)	N/A	N/A	Gutter X Slope (%)	N/A
N/A	Painted X Walk1?	Yes	N/A	Painted X Walk2?	N/A
	X Walk 1 Direction	To W		X Walk 2 Direction	N/A
N/A	X Walk 1 Width (in)	111.0	N/A	X Walk 2 Width (in)	N/A
	X Walk 1 Slope (%)	2.3		X Walk 2 Slope (%)	N/A
	X Walk 1 X Slope (%)	1.2		X Walk 2 X Slope (%)	N/A

N/A	Ramp inside XWalk1?	Yes	N/A	Ramp inside XWalk2?	N/A
	Road Slope (%)	N/A	N/A	Clear Space?	N/A
	Road X Slope (%)	N/A	N/A	Clear Space to XWalk (in)	N/A
N/A	Any Obstructions?	N/A	N/A	Storm Grate/Utility Hazard?	N/A
	Obstruction Type			Storm Grate/Utility Type	
		N/A			N/A
			Yes	Surface Condition? (G/P)	Good

**Remove & Replace Entire Ramp.**

Total Cost: \$ 1850.00
