## **Access Compliance Report Public Rights-of-Way** (Curb Ramps)

Intersection ID: 44305 Main Street: VALERIE DR Cross Street: MALLORY TAYLOR LN Location: SW **Overall Compliance: No Severity Score:** ADA ID: 76311D501291 Ramp Type: PerpDiag Initial Pass/Fail: Fail 8.75

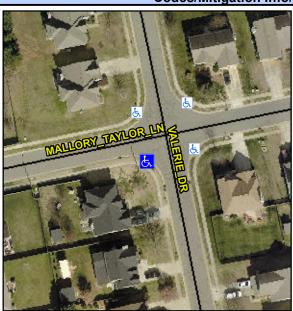
Possible Solutions: Remove & Replace Curb Ramp With Two New Directional Ramps or Equivalent. Surveyor Notes: N/A PROW/ADA: Not Found, R304.5.1
