# Access Compliance Report

## Public Rights-of-Way

### (Curb Ramps)

| Intersection ID: 46206 | Main Street: LOROPETALUM_RD | Cross Street: SNOWBELL_CT | Location: NE |

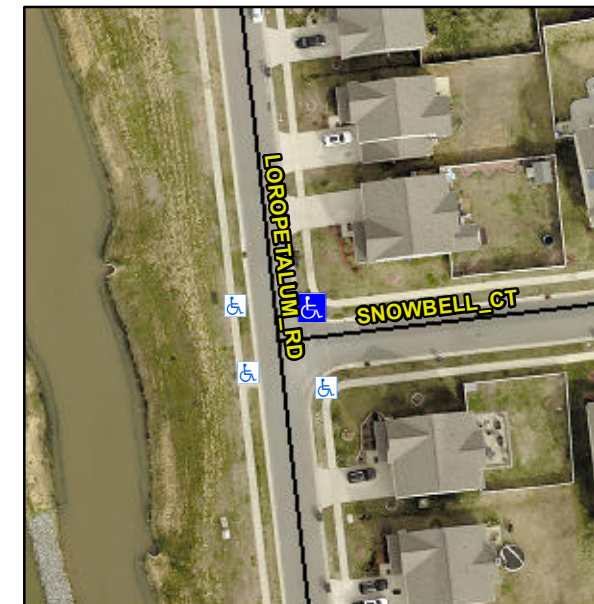
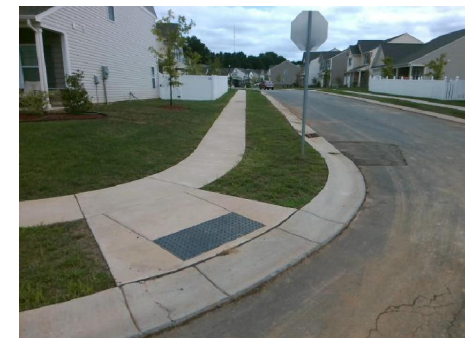
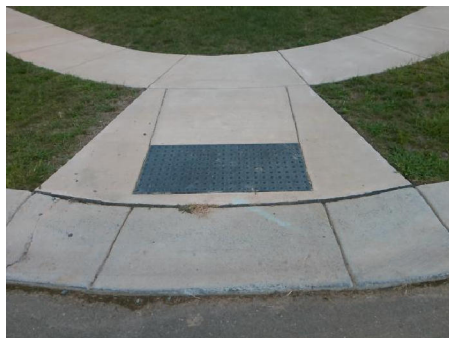
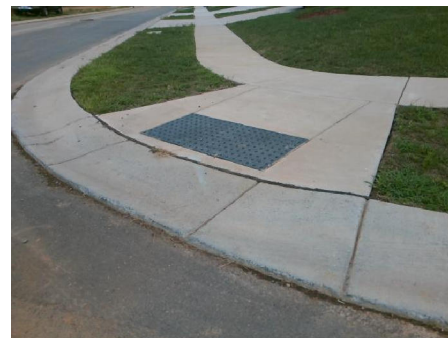
**Not Found, R304.5.3, R305.2, R302.7, R302.7.2, R304.5.4**

| Compliance | Description | Data | Compliance | Description | Data |
|---|---|---|---|---|---|
| Yes | Ramp Width (in) | 48.5 | No | BlendTrans XSlope (%) | 2.7 |
| No | Landing X Slope (%) | 3.6 | Yes | DWS Full Width? | Yes |
| N/A | Landing Curb? (Y/N) | No | No | DWS Offset (in) | 5.0 |
| No | Gutter Ponding? | Yes | No | Gutter Slope (%) | 6.8 |
| No | Gutter Lip Ht (in) | 2.0 | No | Gutter X Slope (%) | 4.0 |
| | | | No | Curb Slope (%) | 13.5 |

**Remove & Replace Curb Ramp With Two New Directional Ramps or Equivalent. Remove & Replace Gutter.**

Total Cost: \$ 3950.00
