# Access Compliance Report

## Public Rights-of-Way

### (Curb Ramps)

| Intersection ID: 45521 | Main Street: HEDGEROW_PARK_RD | Cross Street: MEADOW_BOTTOM_RD | Location: S |

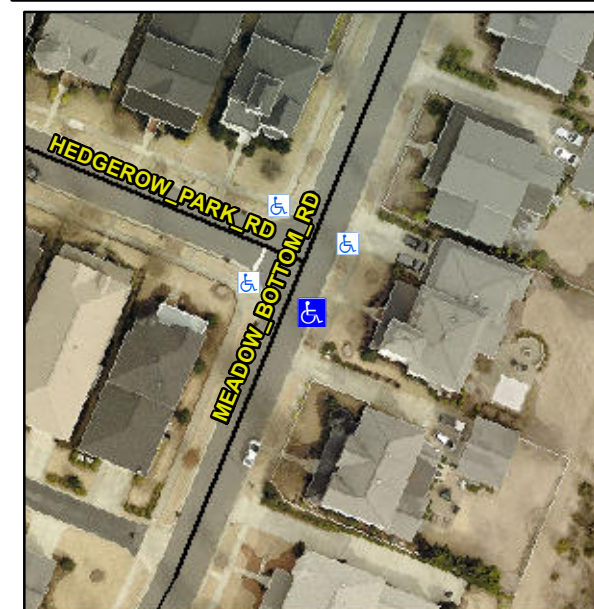
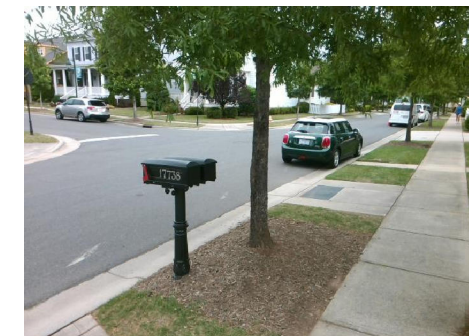
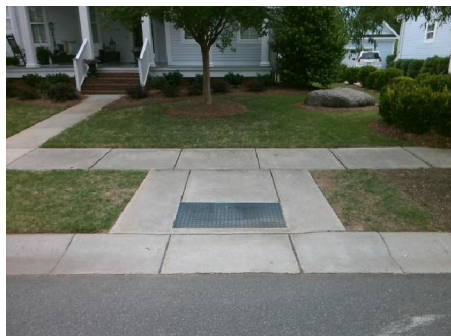
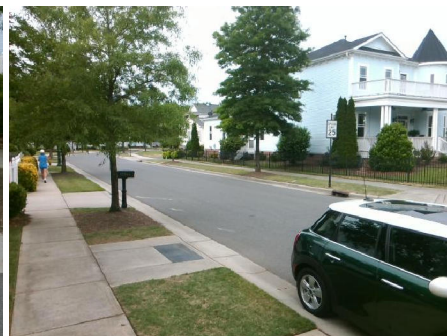
**Not Found, R304.2.1, R304.2.2-Perp, R304.3.2-Para, R305.2**

| Compliance | Description | Data | Compliance | Description | Data |
|---|---|---|---|---|---|
| No | Landing Length (in) | 47.0 | Yes | DWS Provided? | Yes |
| No | Landing Slope (%) | 4.4 | Yes | DWS Length (in) | 24.5 |
| N/A | Landing Curb? (Y/N) | No | No | DWS Offset (in) | 4.0 |

**Remove & Replace Entire Ramp.**

Total Cost: \$ 1850.00
