# Access Compliance Report

## Public Rights-of-Way

### (Curb Ramps)

Intersection ID: 44271	Main Street: BRITTNI_DAYLE_DR	Cross Street: TRAVIS_FLOYD_LN	Location:	N
ADA ID: 763F0D88BE53	Ramp Type: Perp	Initial Pass/Fail: Fail	Overall Compliance: No	Severity Score: 13.75
Codes/Mitigation Info/Possible Solution		Field Measurements/Component Compliance

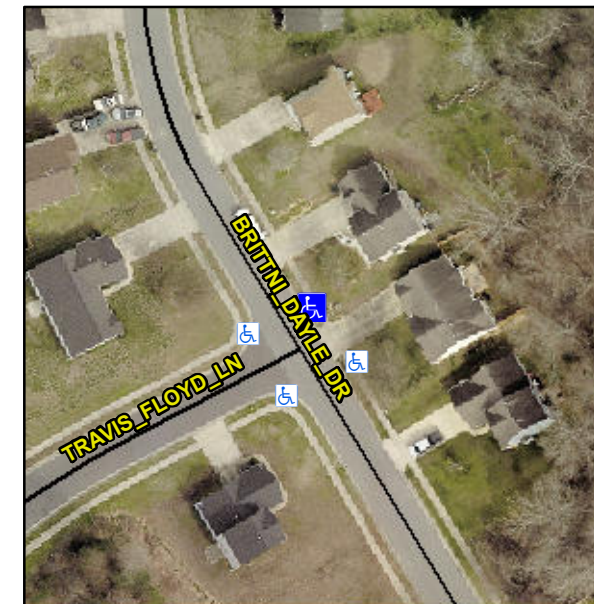
**N/A**

**Not Found, R304.2.2**

Compliance	Description	Data	Compliance	Description	Data
N/A	Ramp Length (in)	48.0	No	Ramp Slope (%)	9.2
Yes	Ramp Width (in)	50.0	Yes	Ramp XSlope (%)	4.2
N/A	Flare Type LT	N/A	N/A	Flare Type RT	N/A
N/A	Flare Slope LT (%)	N/A	N/A	Flare Slope RT (%)	N/A
N/A	Flare Traversable LT?	N/A	N/A	Flare Traversable RT?	N/A
N/A	Landing Length (in)	N/A	N/A	DWS Provided?	N/A
N/A	Landing Width (in)	N/A	N/A	DWS Contrast?	N/A
N/A	Landing Slope (%)	N/A	N/A	DWS Length (in)	N/A
N/A	Landing X Slope (%)	N/A	N/A	DWS Full Width?	N/A
N/A	Landing Curb? (Y/N)	N/A	N/A	DWS Offset (in)	N/A
N/A	Shared Landing?	N/A			
N/A	Gutter Ponding?	N/A	N/A	Gutter Slope (%)	N/A
N/A	Gutter Lip Ht (in)	N/A	N/A	Gutter X Slope (%)	N/A
N/A	Painted X Walk1?	No	N/A	Painted X Walk2?	N/A
	X Walk 1 Direction	To SW		X Walk 2 Direction	N/A
N/A	X Walk 1 Width (in)	N/A	N/A	X Walk 2 Width (in)	N/A
	X Walk 1 Slope (%)	2.5		X Walk 2 Slope (%)	N/A
	X Walk 1 X Slope (%)	5.4		X Walk 2 X Slope (%)	N/A

N/A	Ramp inside XWalk1?	N/A	N/A	Ramp inside XWalk2?	N/A
	Road Slope (%)	N/A	N/A	Clear Space?	N/A
	Road X Slope (%)	N/A	N/A	Clear Space to XWalk (in)	N/A
N/A	Any Obstructions?	N/A	N/A	Storm Grate/Utility Hazard?	N/A
	Obstruction Type			Storm Grate/Utility Type	
		N/A			N/A
			Yes	Surface Condition? (G/P)	Good

**Remove & Replace Entire Ramp.**

Total Cost: \$ 1850.00
