# Access Compliance Report

## Public Rights-of-Way

### (Curb Ramps)

| Intersection ID: 28012 | Main Street: EDINDALE_DR | Cross Street: PROVIDENCE_RD_WEST | Location: NE |

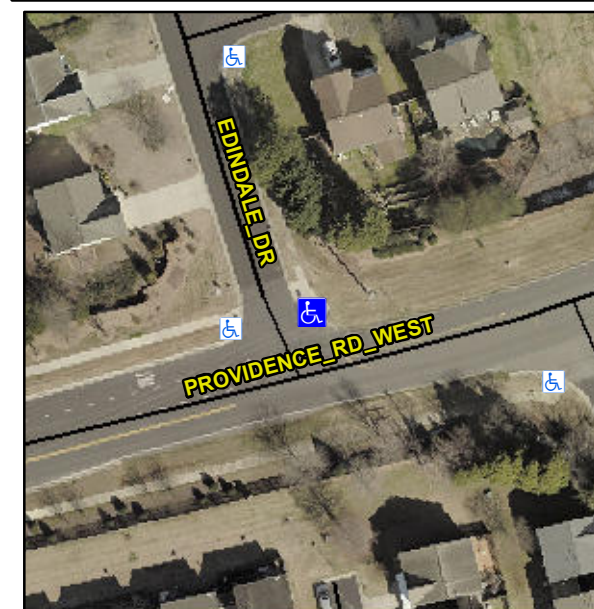
| ADA ID: 7641530A7FF0 | Ramp Type: Perp | Initial Pass/Fail: Fail | Overall Compliance: No |

**Not Found, R304.5.3**

| Compliance | Description | Data | Compliance | Description | Data |
|---|---|---|---|---|---|
| N/A | Ramp Length (in) | 50.0 | Yes | Ramp Slope (%) | 5.5 |
| Yes | Ramp Width (in) | 55.0 | No | Ramp XSlope (%) | 5.3 |

**Remove & Replace Entire Ramp.**

Total Cost: \$ 1850.00
