Access Compliance Report Public Rights-of-Way (Curb Ramps)

Intersection ID: 11644 Main Street: HILLIARD DR **Cross Street: PALM AV** Location: SE Ramp Type: Combination1 Initial Pass/Fail: Fail **Overall Compliance: No** ADA ID: 76451AA8CB68 Severity Score: 46.25

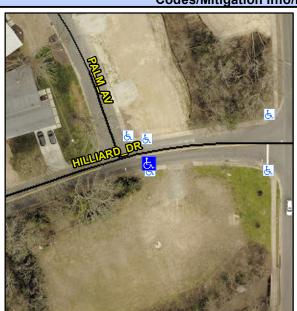
,				
Yes	Ramp Width (in)	50.0	No	Ramp XSlope (%)	5.8
N/A	Flare Type LT	N/A	N/A	Flare Type RT	N/A
N/A	Flare Slope LT (%)	N/A	N/A	Flare Slope RT (%)	N/A
N/A	Flare Traversable LT?	N/A	N/A	Flare Traversable RT?	N/A
N/A	Landing Length (in)	N/A	N/A	DWS Provided?	N/A
N/A	Landing Width (in)	N/A	N/A	DWS Contrast?	N/A
N/A	Landing Slope (%)	N/A	N/A	DWS Length (in)	N/A
N/A	Landing X Slope (%)	N/A	N/A	DWS Full Width?	N/A
N/A	Landing Curb? (Y/N)	N/A	N/A	DWS Offset (in)	N/A
N/A	Shared Landing?	N/A			
N/A	Gutter Ponding?	N/A	N/A	Gutter Slope (%)	N/A
N/A	Gutter Lip Ht (in)	N/A	N/A	Gutter X Slope (%)	N/A
N/A	Painted X Walk1?	No	N/A	Painted X Walk2?	N/A
	X Walk 1 Direction	To N		X Walk 2 Direction	N/A
	X Walk 1 Width (in)	N/A		X Walk 2 Width (in)	N/A
	X Walk 1 Slope (%)	7.1		X Walk 2 Slope (%)	N/A
	X Walk 1 X Slope (%)	7.2		X Walk 2 X Slope (%)	N/A
N/A	Ramp inside XWalk1?	N/A	N/A	Ramp inside XWalk2?	N/A
	Road Slope (%)	N/A		Clear Space?	N/A

Possible Solutions: Compliance Description Remove & Replace Entire Ramp. N/A No Yes Yes N/A Yes Surveyor Notes: N/A N/A LT RP < 5% N/A N/A N/A PROW/ADA: N/A R304.5.1, R304.5.3, R304.3.2 N/A N/A N/A N/A N/A N/A
