# Access Compliance Report

## Public Rights-of-Way

### (Curb Ramps)

Intersection ID: 50768	Main Street: TOWERING_PINE_DR	Cross Street: SUTTONVIEW_DR	Location: SE
ADA ID: 76553F1A2088	Ramp Type: Perp	Initial Pass/Fail: Fail	Overall Compliance: No
Severity Score: 10			
Codes/Mitigation Info/Possible Solution		Field Measurements/Component Compliance

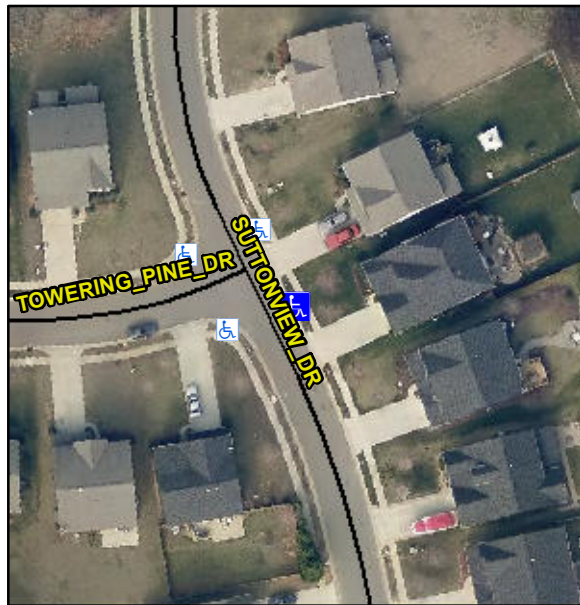
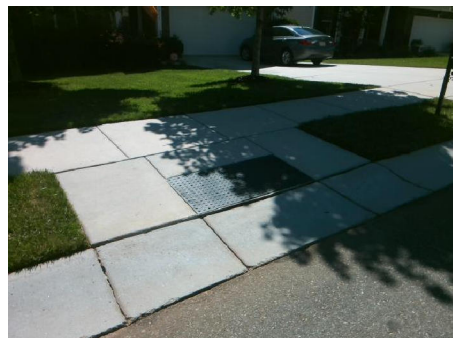
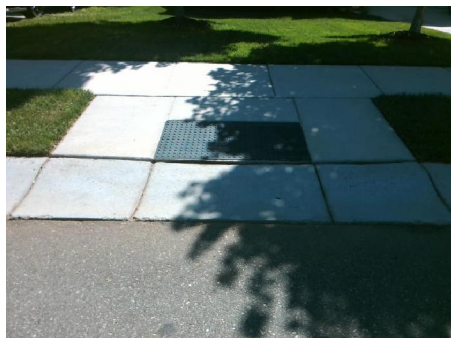
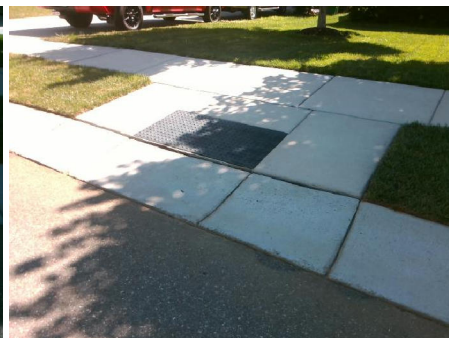
**Not Found, R304.5.1, R304.5.3**

Compliance	Description	Data	Compliance	Description	Data
N/A	Ramp Length (in)	47.0	Yes	Ramp Slope (%)	5.1
No	Ramp Width (in)	47.5	No	Ramp XSlope (%)	3.6
N/A	Flare Type LT	N/A	N/A	Flare Type RT	N/A
N/A	Flare Slope LT (%)	N/A	N/A	Flare Slope RT (%)	N/A
N/A	Flare Traversable LT?	N/A	N/A	Flare Traversable RT?	N/A
N/A	Landing Length (in)	N/A	N/A	DWS Provided?	N/A
N/A	Landing Width (in)	N/A	N/A	DWS Contrast?	N/A
N/A	Landing Slope (%)	N/A	N/A	DWS Length (in)	N/A
N/A	Landing X Slope (%)	N/A	N/A	DWS Full Width?	N/A
N/A	Landing Curb? (Y/N)	N/A	N/A	DWS Offset (in)	N/A
N/A	Shared Landing?	N/A			
N/A	Gutter Ponding?	N/A	N/A	Gutter Slope (%)	N/A
N/A	Gutter Lip Ht (in)	N/A	N/A	Gutter X Slope (%)	N/A
N/A	Painted X Walk1?	No	N/A	Painted X Walk2?	N/A
	X Walk 1 Direction	To W		X Walk 2 Direction	N/A
N/A	X Walk 1 Width (in)	N/A	N/A	X Walk 2 Width (in)	N/A
	X Walk 1 Slope (%)	1.9		X Walk 2 Slope (%)	N/A
	X Walk 1 X Slope (%)	2.8		X Walk 2 X Slope (%)	N/A

N/A	Ramp inside XWalk1?	N/A	N/A	Ramp inside XWalk2?	N/A
	Road Slope (%)	N/A	N/A	Clear Space?	N/A
	Road X Slope (%)	N/A	N/A	Clear Space to XWalk (in)	N/A
N/A	Any Obstructions?	N/A	N/A	Storm Grate/Utility Hazard?	N/A
	Obstruction Type			Storm Grate/Utility Type	
		N/A			N/A
			Yes	Surface Condition? (G/P)	Good

**Remove & Replace Entire Ramp.**
