Access Compliance Report

Public Rights-of-Way

(Curb Ramps)

Intersection ID: 16139	Main Street: BILTMORE_DR	Cross Street: CHEROKEE_RD	Location: SW
ADA ID: 766570DE97C8	Ramp Type: Perp	Initial Pass/Fail: Fail	Overall Compliance: No
Severity Score: 1.25			
Codes/Mitigation Info/Possible Solution		Field Measurements/Component Compliance

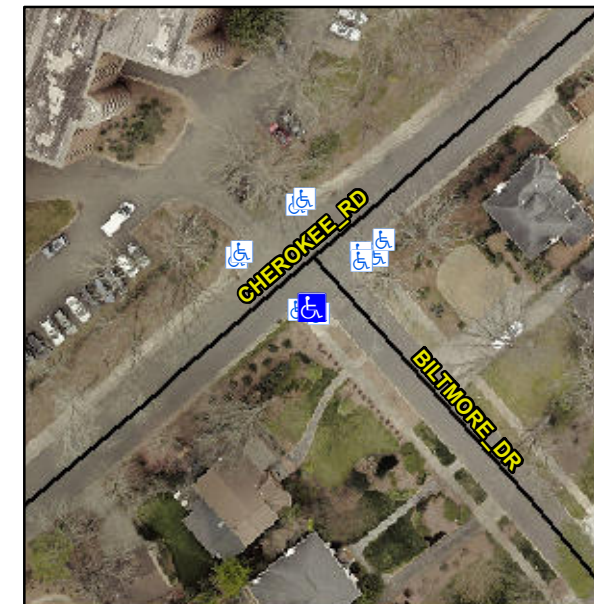
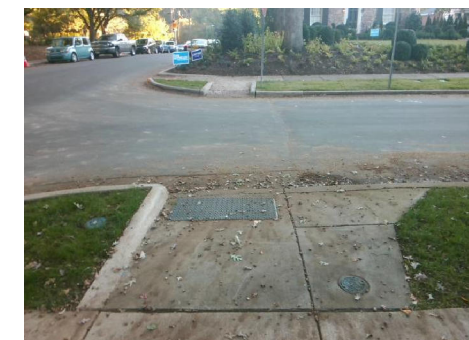
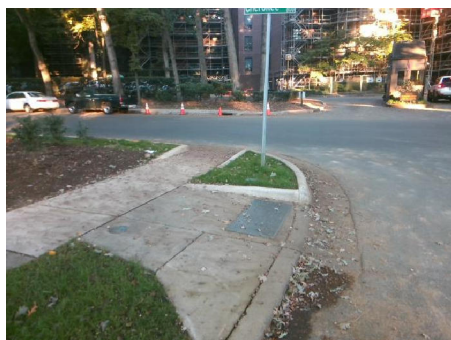
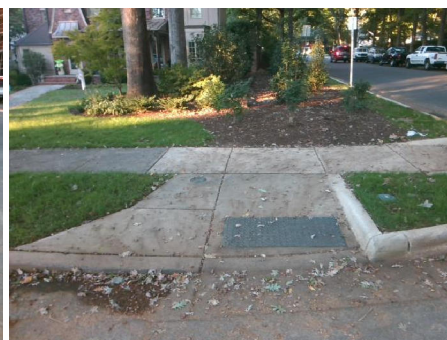
Not Found, R304.5.3

Compliance	Description	Data	Compliance	Description	Data
N/A	Ramp Length (in)	78.0	Yes	Ramp Slope (%)	5.3
Yes	Ramp Width (in)	59.0	No	Ramp XSlope (%)	2.7
N/A	Flare Type LT	N/A	N/A	Flare Type RT	N/A
N/A	Flare Slope LT (%)	N/A	N/A	Flare Slope RT (%)	N/A
N/A	Flare Traversable LT?	N/A	N/A	Flare Traversable RT?	N/A
N/A	Landing Length (in)	N/A	N/A	DWS Provided?	N/A
N/A	Landing Width (in)	N/A	N/A	DWS Contrast?	N/A
N/A	Landing Slope (%)	N/A	N/A	DWS Length (in)	N/A
N/A	Landing X Slope (%)	N/A	N/A	DWS Full Width?	N/A
N/A	Landing Curb? (Y/N)	N/A	N/A	DWS Offset (in)	N/A
N/A	Shared Landing?	N/A			
N/A	Gutter Ponding?	N/A	N/A	Gutter Slope (%)	N/A
N/A	Gutter Lip Ht (in)	N/A	N/A	Gutter X Slope (%)	N/A
N/A	Painted X Walk1?	No	N/A	Painted X Walk2?	N/A
	X Walk 1 Direction	To NE		X Walk 2 Direction	N/A
N/A	X Walk 1 Width (in)	N/A	N/A	X Walk 2 Width (in)	N/A
	X Walk 1 Slope (%)	2.4		X Walk 2 Slope (%)	N/A
	X Walk 1 X Slope (%)	2.8		X Walk 2 X Slope (%)	N/A

N/A	Ramp inside XWalk1?	N/A	N/A	Ramp inside XWalk2?	N/A
	Road Slope (%)	N/A	N/A	Clear Space?	N/A
	Road X Slope (%)	N/A	N/A	Clear Space to XWalk (in)	N/A
N/A	Any Obstructions?	N/A	N/A	Storm Grate/Utility Hazard?	N/A
	Obstruction Type			Storm Grate/Utility Type	
		N/A			N/A
			Yes	Surface Condition? (G/P)	Good

Remove & Replace Entire Ramp.

Total Cost: \$ 1850.00
