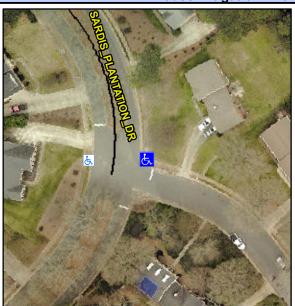
Intersection ID: N/A Main Street: SARDIS_PLANTATION_DR Cross Street: LINVILLE_DR Location: NE **Overall Compliance: No** ADA ID: 766837B82849 Ramp Type: PerpDiag Initial Pass/Fail: Fail **Severity Score:** 50

Field Measurements/Component Compliance						
Compliance Description		Data	Comp	oliance Description	Data	
N/A	Ramp Length (in)	83.0	No	Ramp Slope (%)	13.5	
Yes	Ramp Width (in)	48.0	No	Ramp XSlope (%)	8.4	
N/A	Flare Type LT	N/A	N/A	Flare Type RT	N/A	
N/A	Flare Slope LT (%)	N/A	N/A	Flare Slope RT (%)	N/A	
N/A	Flare Traversable LT?	N/A	N/A	Flare Traversable RT?	N/A	
N/A	Landing Length (in)	N/A	N/A	DWS Provided?	N/A	
N/A	Landing Width (in)	N/A	N/A	DWS Contrast?	N/A	
N/A	Landing Slope (%)	N/A	N/A	DWS Length (in)	N/A	
N/A	Landing X Slope (%)	N/A	N/A	DWS Full Width?	N/A	
N/A	Landing Curb? (Y/N)	N/A	N/A	DWS Offset (in)	N/A	
N/A	Shared Landing?	N/A				
N/A	Gutter Ponding?	N/A	N/A	Gutter Slope (%)	N/A	
N/A	Gutter Lip Ht (in)	N/A	N/A	Gutter X Slope (%)	N/A	
N/A	Painted X Walk1?	No	N/A	Painted X Walk2?	No	
	X Walk 1 Direction	To NW		X Walk 2 Direction	To SW	
N/A	X Walk 1 Width (in)	N/A	N/A	X Walk 2 Width (in)	N/A	
	X Walk 1 Slope (%)	1.3		X Walk 2 Slope (%)	3.5

X Walk 1 X Slope (%)	5.4		X Walk 2 X Slope (%)	3.3	
N/A	Ramp inside XWalk1?	N/A	N/A	Ramp inside XWalk2?	N/A	
	Road Slope (%)	6.4	N/A	Clear Space?	N/A	
	Road X Slope (%)	1.3	N/A	Clear Space to XWalk (in)	N/A	
N/A	Any Obstructions?	N/A	N/A	Storm Grate/Utility Hazard?	N/A	
	Obstruction Type			Storm Grate/Utility Type		
		N/A			N/A	
			Yes	Surface Condition? (G/P)	Good

Possible Solutions:
Remove & Replace Curb Ramp With Two New Directional Ramps or Equivalent.
Surveyor Notes: N/A
PROW/ADA: Not Found, R304.2.2, R304.5.3

Total Cost: 3200.00
