# Access Compliance Report

## Public Rights-of-Way

### (Curb Ramps)

Intersection ID: 42735	Main Street: WILGROVE WAY DR	Cross Street: SERVICE RD 2 RD	Location: S
ADA ID: 766C31DE901C	Ramp Type: Perp	Initial Pass/Fail: Fail	Overall Compliance: No
		Severity Score: 22.5	
Codes/Mitigation Info/Possible Solution		Field Measurements/Component Compliance

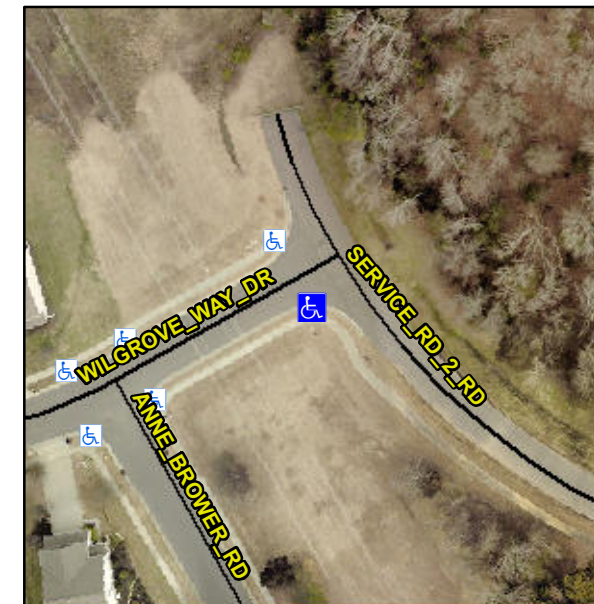
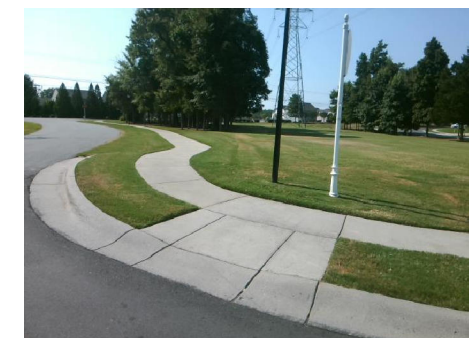
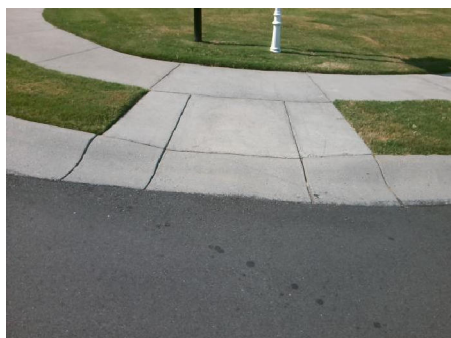
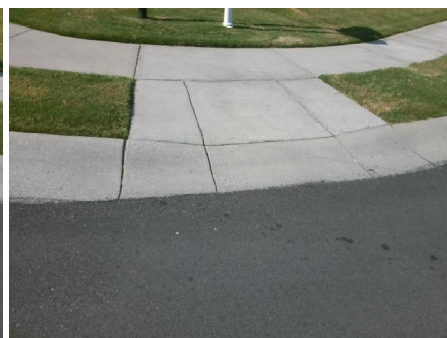
**Not Found, R304.5.1, R304.2.2, R304.5.3**

Compliance	Description	Data	Compliance	Description	Data
N/A	Ramp Length (in)	47.0	No	Ramp Slope (%)	9.7
No	Ramp Width (in)	42.0	No	Ramp XSlope (%)	3.9
N/A	Flare Type LT	N/A	N/A	Flare Type RT	N/A
N/A	Flare Slope LT (%)	N/A	N/A	Flare Slope RT (%)	N/A
N/A	Flare Traversable LT?	N/A	N/A	Flare Traversable RT?	N/A
N/A	Landing Length (in)	N/A	N/A	DWS Provided?	N/A
N/A	Landing Width (in)	N/A	N/A	DWS Contrast?	N/A
N/A	Landing Slope (%)	N/A	N/A	DWS Length (in)	N/A
N/A	Landing X Slope (%)	N/A	N/A	DWS Full Width?	N/A
N/A	Landing Curb? (Y/N)	N/A	N/A	DWS Offset (in)	N/A
N/A	Shared Landing?	N/A			
N/A	Gutter Ponding?	N/A	N/A	Gutter Slope (%)	N/A
N/A	Gutter Lip Ht (in)	N/A	N/A	Gutter X Slope (%)	N/A
N/A	Painted X Walk1?	No	N/A	Painted X Walk2?	N/A
	X Walk 1 Direction	To NW		X Walk 2 Direction	N/A
N/A	X Walk 1 Width (in)	N/A	N/A	X Walk 2 Width (in)	N/A
	X Walk 1 Slope (%)	2.5		X Walk 2 Slope (%)	N/A
	X Walk 1 X Slope (%)	5.7		X Walk 2 X Slope (%)	N/A

N/A	Ramp inside XWalk1?	N/A	N/A	Ramp inside XWalk2?	N/A
	Road Slope (%)	N/A	N/A	Clear Space?	N/A
	Road X Slope (%)	N/A	N/A	Clear Space to XWalk (in)	N/A
N/A	Any Obstructions?	N/A	N/A	Storm Grate/Utility Hazard?	N/A
	Obstruction Type			Storm Grate/Utility Type	
		N/A			N/A
			Yes	Surface Condition? (G/P)	Good

**Remove & Replace Entire Ramp.**

**\$ 1850.00**
