Access Compliance Report

Public Rights-of-Way

(Curb Ramps)

Intersection ID: 6149	Main Street: STATESVILLE_RD	Cross Street: SUNTRACE_WY	Location: SW
ADA ID: 766D18F273C9	Ramp Type: Perp	Initial Pass/Fail: Fail	Overall Compliance: No
Severity Score: 8.75			
Codes/Mitigation Info/Possible Solution		Field Measurements/Component Compliance

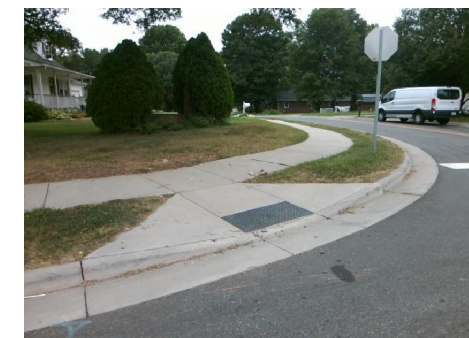
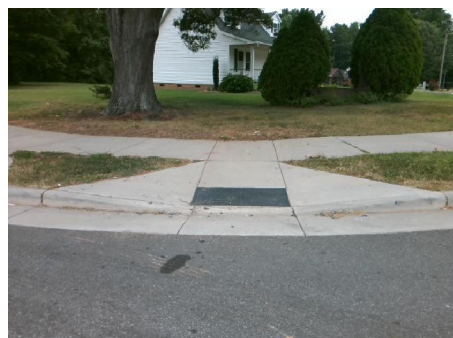
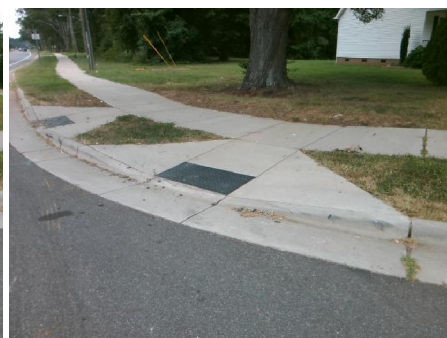
Not Found, R304.5.1

Compliance	Description	Data	Compliance	Description	Data
N/A	Ramp Length (in)	73.5	Yes	Ramp Slope (%)	7.5
No	Ramp Width (in)	46.0	Yes	Ramp XSlope (%)	1.4
N/A	Flare Type LT	N/A	N/A	Flare Type RT	N/A
N/A	Flare Slope LT (%)	N/A	N/A	Flare Slope RT (%)	N/A
N/A	Flare Traversable LT?	N/A	N/A	Flare Traversable RT?	N/A
N/A	Landing Length (in)	N/A	N/A	DWS Provided?	N/A
N/A	Landing Width (in)	N/A	N/A	DWS Contrast?	N/A
N/A	Landing Slope (%)	N/A	N/A	DWS Length (in)	N/A
N/A	Landing X Slope (%)	N/A	N/A	DWS Full Width?	N/A
N/A	Landing Curb? (Y/N)	N/A	N/A	DWS Offset (in)	N/A
N/A	Shared Landing?	N/A			
N/A	Gutter Ponding?	N/A	N/A	Gutter Slope (%)	N/A
N/A	Gutter Lip Ht (in)	N/A	N/A	Gutter X Slope (%)	N/A
N/A	Painted X Walk1?	No	N/A	Painted X Walk2?	N/A
	X Walk 1 Direction	To N		X Walk 2 Direction	N/A
N/A	X Walk 1 Width (in)	N/A	N/A	X Walk 2 Width (in)	N/A
	X Walk 1 Slope (%)	0.4		X Walk 2 Slope (%)	N/A
	X Walk 1 X Slope (%)	2.6		X Walk 2 X Slope (%)	N/A

N/A	Ramp inside XWalk1?	N/A	N/A	Ramp inside XWalk2?	N/A
	Road Slope (%)	N/A	N/A	Clear Space?	N/A
	Road X Slope (%)	N/A	N/A	Clear Space to XWalk (in)	N/A
N/A	Any Obstructions?	N/A	N/A	Storm Grate/Utility Hazard?	N/A
	Obstruction Type			Storm Grate/Utility Type	
		N/A			N/A
			Yes	Surface Condition? (G/P)	Good

Remove & Replace Entire Ramp.
