Access Compliance Report

Public Rights-of-Way

(Curb Ramps)

Intersection ID: 28359	Main Street: GREENFORD_CT	Cross Street: NEWTON_LN	Location: SW
ADA ID: 766E6EDE418C	Ramp Type: Perp	Initial Pass/Fail: Fail	Overall Compliance: No
			Severity Score: 21.25

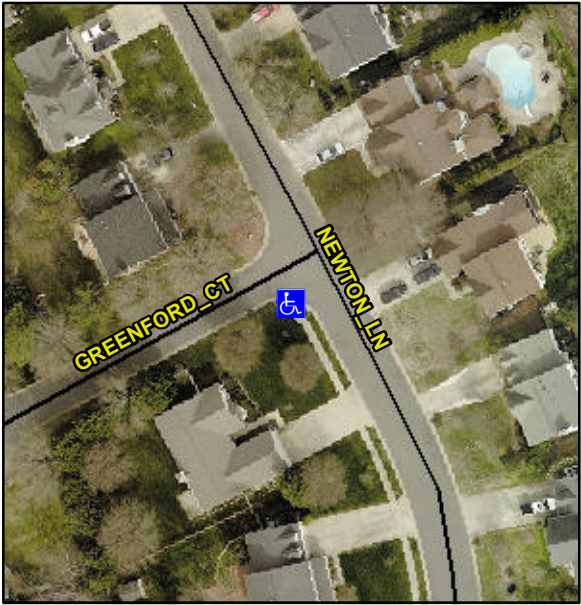
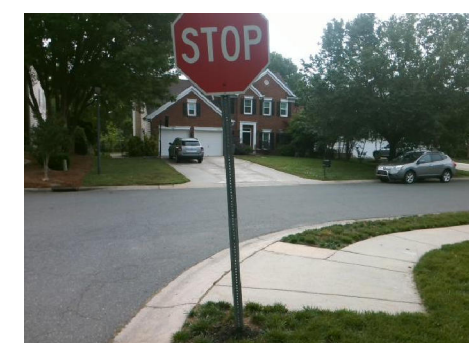
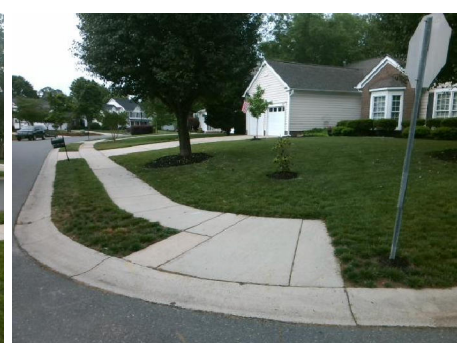
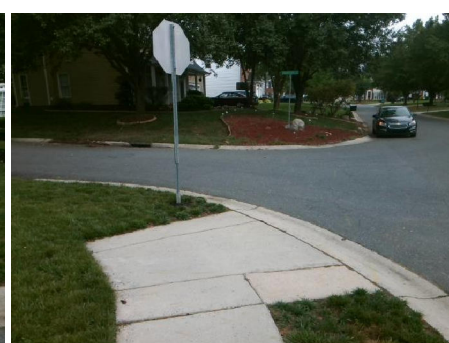
Possible Solutions:		Compliance	Description	Data
	Remove & Replace Entire Ramp.		No	Ramp Length (in)	84.0
			No	Ramp Width (in)	38.0
			N/A	Flare Type LT	N/A
			N/A	Flare Slope LT (%)	N/A
			N/A	Flare Traversable LT?	N/A
			N/A	Landing Length (in)	N/A
			N/A	Landing Width (in)	N/A
			N/A	Landing Slope (%)	N/A
			N/A	Landing X Slope (%)	N/A
<p>Surveyor Notes:</p> <p>N/A</p> <p>PROW/ADA:</p> <p>Not Found, R304.5.1, R304.2.2</p>			N/A	Flare Type RT	N/A
			N/A	Flare Slope RT (%)	N/A
			N/A	Flare Traversable RT?	N/A
			N/A	DWS Provided?	N/A
			N/A	DWS Contrast?	N/A
			N/A	DWS Length (in)	N/A
			N/A	DWS Full Width?	N/A
			N/A	DWS Offset (in)	N/A
			N/A	Shared Landing?	N/A
			N/A	Gutter Ponding?	N/A
			N/A	Gutter Lip Ht (in)	N/A
			N/A	Painted X Walk1?	No
				X Walk 1 Direction	To E
			N/A	X Walk 1 Width (in)	N/A
				X Walk 1 Slope (%)	1.4

X Walk 1 X Slope (%)	0.5
			N/A	Ramp inside XWalk1?	N/A
				Road Slope (%)	0.5
				Road X Slope (%)	1.4
			N/A	Any Obstructions?	N/A
				Obstruction Type	
Total Cost:		\$ 1850.00			
			N/A		N/A
			Yes	Surface Condition? (G/P)	Good
