Access Compliance Report

(Curb Ramps)

Intersection ID: 6149	Main Street: STATESVILLE_RD	Cross Street: SUNTRACE_WY	Location: NW
ADA ID: 7673F7B74956	Ramp Type: PerpDiag	Initial Pass/Fail: Fail	Overall Compliance: No
		Severity Score: 12.5

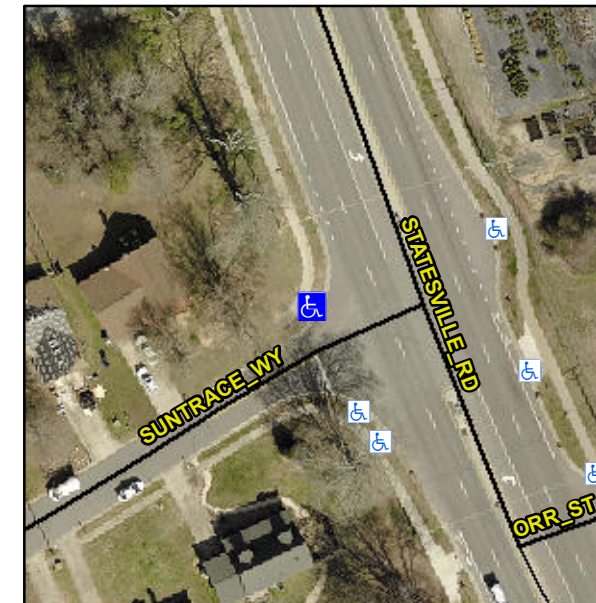
Not Found, R304.2.2

Compliance	Description	Data	Compliance	Description	Data
N/A	Ramp Length (in)	71.0	No	Ramp Slope (%)	10.6
Yes	Ramp Width (in)	48.0	Yes	Ramp XSlope (%)	1.6
N/A	Flare Type LT	N/A	N/A	Flare Type RT	N/A
N/A	Flare Slope LT (%)	N/A	N/A	Flare Slope RT (%)	N/A
N/A	Flare Traversable LT?	N/A	N/A	Flare Traversable RT?	N/A
N/A	Landing Length (in)	N/A	N/A	DWS Provided?	N/A
N/A	Landing Width (in)	N/A	N/A	DWS Contrast?	N/A
N/A	Landing Slope (%)	N/A	N/A	DWS Length (in)	N/A
N/A	Landing X Slope (%)	N/A	N/A	DWS Full Width?	N/A
N/A	Landing Curb? (Y/N)	N/A	N/A	DWS Offset (in)	N/A
N/A	Shared Landing?	N/A			
N/A	Gutter Ponding?	N/A	N/A	Gutter Slope (%)	N/A
N/A	Gutter Lip Ht (in)	N/A	N/A	Gutter X Slope (%)	N/A
N/A	Painted X Walk1?	No	N/A	Painted X Walk2?	No
	X Walk 1 Direction	To E		X Walk 2 Direction	To S
N/A	X Walk 1 Width (in)	N/A	N/A	X Walk 2 Width (in)	N/A
	X Walk 1 Slope (%)	0.8		X Walk 2 Slope (%)	1.5
	X Walk 1 X Slope (%)	2.8		X Walk 2 X Slope (%)	1.5

N/A	Ramp inside XWalk1?	N/A	N/A	Ramp inside XWalk2?	N/A
	Road Slope (%)	3.0	N/A	Clear Space?	N/A
	Road X Slope (%)	0.3	N/A	Clear Space to XWalk (in)	N/A
N/A	Any Obstructions?	N/A	N/A	Storm Grate/Utility Hazard?	N/A
	Obstruction Type			Storm Grate/Utility Type	
		N/A			N/A
		Yes		Surface Condition? (G/P)	Good

Remove & Replace Curb Ramp With Two New Directional Ramps or Equivalent.

Total Cost: \$ 3200.00
