Access Compliance Report

Public Rights-of-Way

(Curb Ramps)

Intersection ID: 3596	Main Street: DARBYSHIRE_PL	Cross Street: TREYBURN_DR	Location: NW
ADA ID: 7681DA0971C3	Ramp Type: Perp	Initial Pass/Fail: Fail	Overall Compliance: No
Severity Score: 12.5			
Codes/Mitigation Info/Possible Solution		Field Measurements/Component Compliance

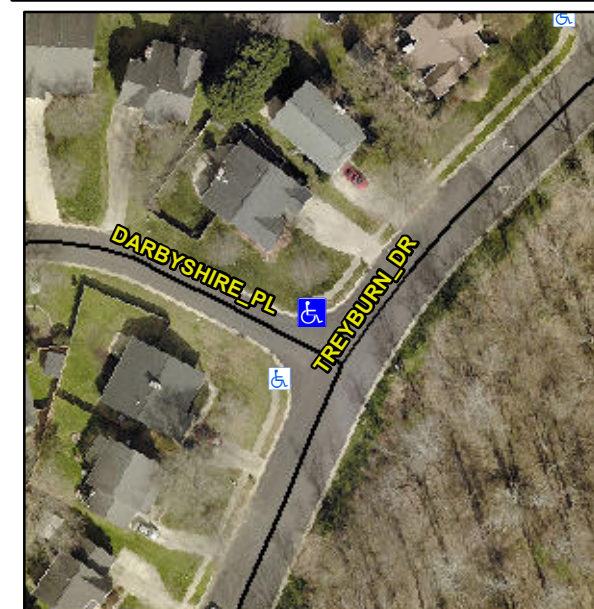
Not Found, R304.2.2

Compliance	Description	Data	Compliance	Description	Data
N/A	Ramp Length (in)	48.0	No	Ramp Slope (%)	9.3
Yes	Ramp Width (in)	48.0	Yes	Ramp XSlope (%)	0.7
N/A	Flare Type LT	N/A	N/A	Flare Type RT	N/A
N/A	Flare Slope LT (%)	N/A	N/A	Flare Slope RT (%)	N/A
N/A	Flare Traversable LT?	N/A	N/A	Flare Traversable RT?	N/A
N/A	Landing Length (in)	N/A	N/A	DWS Provided?	N/A
N/A	Landing Width (in)	N/A	N/A	DWS Contrast?	N/A
N/A	Landing Slope (%)	N/A	N/A	DWS Length (in)	N/A
N/A	Landing X Slope (%)	N/A	N/A	DWS Full Width?	N/A
N/A	Landing Curb? (Y/N)	N/A	N/A	DWS Offset (in)	N/A
N/A	Shared Landing?	N/A			
N/A	Gutter Ponding?	N/A	N/A	Gutter Slope (%)	N/A
N/A	Gutter Lip Ht (in)	N/A	N/A	Gutter X Slope (%)	N/A
N/A	Painted X Walk1?	No	N/A	Painted X Walk2?	N/A
	X Walk 1 Direction	To SW		X Walk 2 Direction	N/A
N/A	X Walk 1 Width (in)	N/A	N/A	X Walk 2 Width (in)	N/A
	X Walk 1 Slope (%)	0.6		X Walk 2 Slope (%)	N/A
	X Walk 1 X Slope (%)	2.0		X Walk 2 X Slope (%)	N/A

N/A	Ramp inside XWalk1?	N/A	N/A	Ramp inside XWalk2?	N/A
	Road Slope (%)	N/A	N/A	Clear Space?	N/A
	Road X Slope (%)	N/A	N/A	Clear Space to XWalk (in)	N/A
N/A	Any Obstructions?	N/A	N/A	Storm Grate/Utility Hazard?	N/A
	Obstruction Type			Storm Grate/Utility Type	
		N/A			N/A
		Yes		Surface Condition? (G/P)	Good

Possible Solutions:

Remove & Replace Entire Ramp.
