## **Access Compliance Report Public Rights-of-Way** (Curb Ramps)

Intersection ID: 17531 Main Street: HILLSIDE AV Cross Street: WESTFIELD RD NE Location: **Overall Compliance: No Severity Score:** ADA ID: 768377A69C9B Ramp Type: PerpDiag Initial Pass/Fail: Fail 22.5

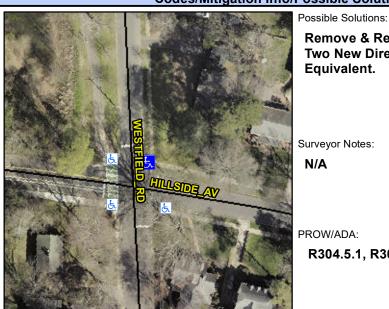
Surveyor Notes: N/A PROW/ADA:

R304.5.1, R304.2.2, R304.5.3

Two New Directional Ramps or

Equivalent.

Compliance Description N/A Remove & Replace Curb Ramp With No N/A N/A
