Access Compliance Report

Public Rights-of-Way

(Curb Ramps)

Intersection ID: 11625	Main Street: E_11TH_ST	Cross Street: N_COLLEGE_ST	Location: E
ADA ID: 768469B7B7AE	Ramp Type: Perp	Initial Pass/Fail: Fail	Overall Compliance: No
Severity Score: 12.5			
Codes/Mitigation Info/Possible Solution		Field Measurements/Component Compliance

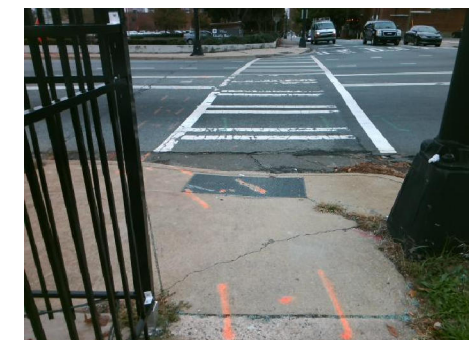
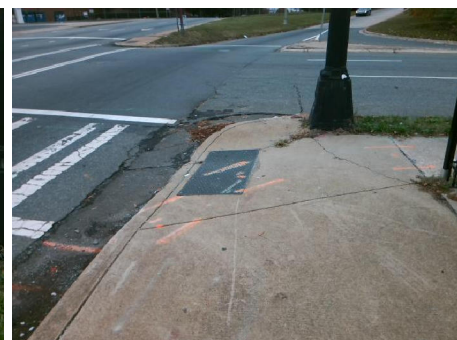
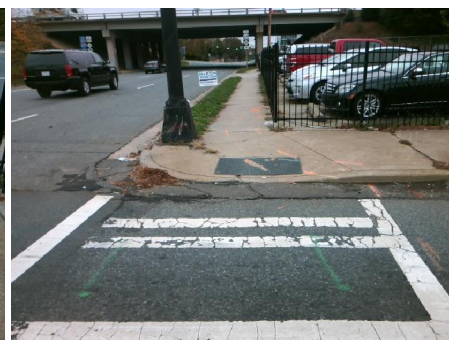
Not Found, R304.2.2

Compliance	Description	Data	Compliance	Description	Data
N/A	Ramp Length (in)	48.0	No	Ramp Slope (%)	10.2
Yes	Ramp Width (in)	48.0	Yes	Ramp XSlope (%)	1.4
N/A	Flare Type LT	N/A	N/A	Flare Type RT	N/A
N/A	Flare Slope LT (%)	N/A	N/A	Flare Slope RT (%)	N/A
N/A	Flare Traversable LT?	N/A	N/A	Flare Traversable RT?	N/A
N/A	Landing Length (in)	N/A	N/A	DWS Provided?	N/A
N/A	Landing Width (in)	N/A	N/A	DWS Contrast?	N/A
N/A	Landing Slope (%)	N/A	N/A	DWS Length (in)	N/A
N/A	Landing X Slope (%)	N/A	N/A	DWS Full Width?	N/A
N/A	Landing Curb? (Y/N)	N/A	N/A	DWS Offset (in)	N/A
N/A	Shared Landing?	N/A			
N/A	Gutter Ponding?	N/A	N/A	Gutter Slope (%)	N/A
N/A	Gutter Lip Ht (in)	N/A	N/A	Gutter X Slope (%)	N/A
N/A	Painted X Walk1?	Yes	N/A	Painted X Walk2?	N/A
	X Walk 1 Direction	To SW		X Walk 2 Direction	N/A
N/A	X Walk 1 Width (in)	112.0	N/A	X Walk 2 Width (in)	N/A
	X Walk 1 Slope (%)	4.1		X Walk 2 Slope (%)	N/A
	X Walk 1 X Slope (%)	2.2		X Walk 2 X Slope (%)	N/A

N/A	Ramp inside XWalk1?	Yes	N/A	Ramp inside XWalk2?	N/A
	Road Slope (%)	N/A	N/A	Clear Space?	N/A
	Road X Slope (%)	N/A	N/A	Clear Space to XWalk (in)	N/A
N/A	Any Obstructions?	N/A	N/A	Storm Grate/Utility Hazard?	N/A
	Obstruction Type			Storm Grate/Utility Type	
		N/A			N/A
		Yes		Surface Condition? (G/P)	Good

Possible Solutions:

Remove & Replace Entire Ramp.
