# Access Compliance Report

## Public Rights-of-Way

### (Curb Ramps)

Intersection ID: N/A	Main Street: AGNEW_DR	Cross Street: VAWTER_RD	Location: NW
ADA ID: 76848C791611	Ramp Type: Perp	Initial Pass/Fail: Fail	Overall Compliance: No
Severity Score: 10			
Codes/Mitigation Info/Possible Solution		Field Measurements/Component Compliance

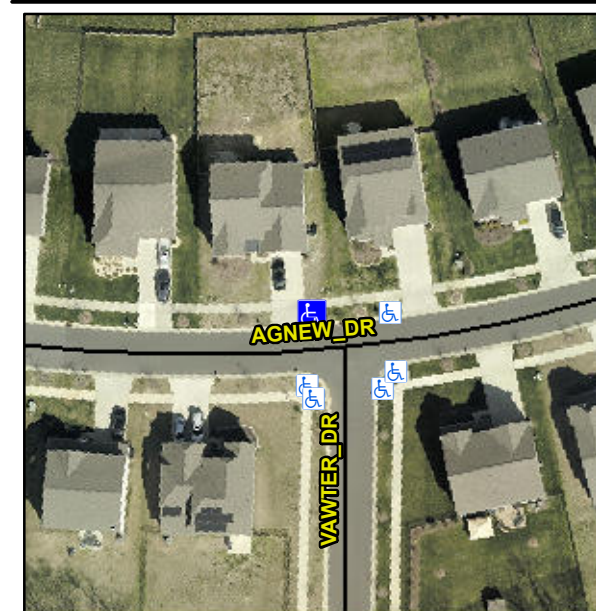
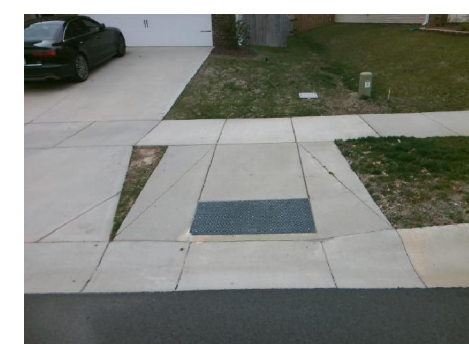
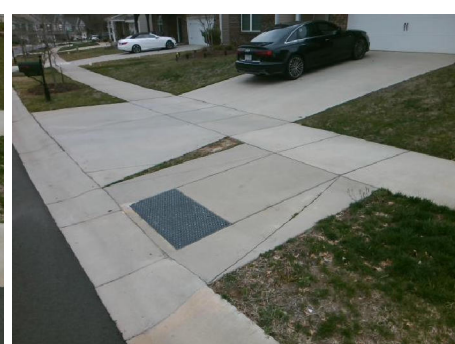
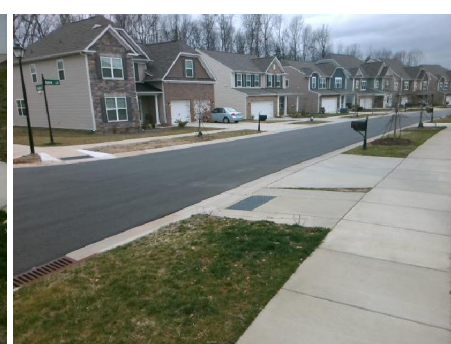
**Not Found, R304.5.1**

Compliance	Description	Data	Compliance	Description	Data
N/A	Ramp Length (in)	93.0	Yes	Ramp Slope (%)	6.8
No	Ramp Width (in)	46.0	Yes	Ramp XSlope (%)	2.6
N/A	Flare Type LT	N/A	N/A	Flare Type RT	N/A
N/A	Flare Slope LT (%)	N/A	N/A	Flare Slope RT (%)	N/A
N/A	Flare Traversable LT?	N/A	N/A	Flare Traversable RT?	N/A
N/A	Landing Length (in)	N/A	N/A	DWS Provided?	N/A
N/A	Landing Width (in)	N/A	N/A	DWS Contrast?	N/A
N/A	Landing Slope (%)	N/A	N/A	DWS Length (in)	N/A
N/A	Landing X Slope (%)	N/A	N/A	DWS Full Width?	N/A
N/A	Landing Curb? (Y/N)	N/A	N/A	DWS Offset (in)	N/A
N/A	Shared Landing?	N/A			
N/A	Gutter Ponding?	N/A	N/A	Gutter Slope (%)	N/A
N/A	Gutter Lip Ht (in)	N/A	N/A	Gutter X Slope (%)	N/A
N/A	Painted X Walk1?	No	N/A	Painted X Walk2?	N/A
	X Walk 1 Direction	To S		X Walk 2 Direction	N/A
N/A	X Walk 1 Width (in)	N/A	N/A	X Walk 2 Width (in)	N/A
	X Walk 1 Slope (%)	3.1		X Walk 2 Slope (%)	N/A
	X Walk 1 X Slope (%)	3.0		X Walk 2 X Slope (%)	N/A

N/A	Ramp inside XWalk1?	N/A	N/A	Ramp inside XWalk2?	N/A
	Road Slope (%)	N/A	N/A	Clear Space?	N/A
	Road X Slope (%)	N/A	N/A	Clear Space to XWalk (in)	N/A
N/A	Any Obstructions?	N/A	N/A	Storm Grate/Utility Hazard?	N/A
	Obstruction Type			Storm Grate/Utility Type	
		N/A			N/A
		Yes		Surface Condition? (G/P)	Good

**Remove & Replace Entire Ramp.**

**\$ 1850.00**
