# Access Compliance Report

## Public Rights-of-Way

### (Curb Ramps)

Intersection ID: N/A	Main Street: REGAL_OAKS_DR	Cross Street: WINDING_CEDAR_TR	Location: NE
ADA ID: 76861E553EA9	Ramp Type: PerpDiag	Initial Pass/Fail: Fail	Overall Compliance: No
Severity Score: 25			
Codes/Mitigation Info/Possible Solution		Field Measurements/Component Compliance

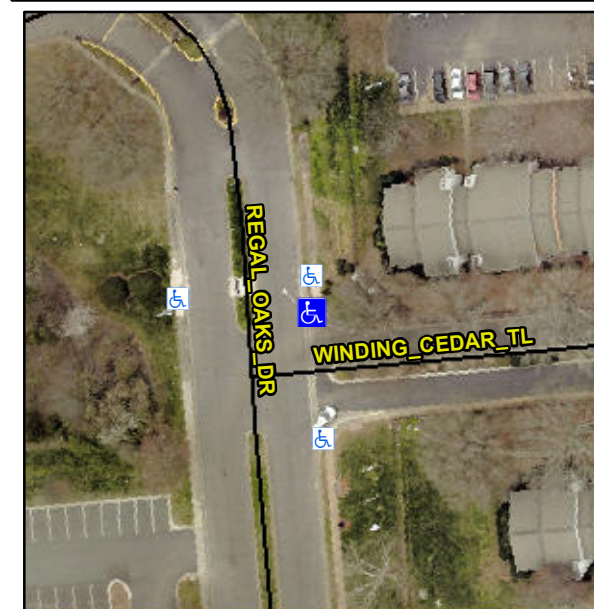
**Not Found, R304.2.2, R304.5.3**

Compliance	Description	Data	Compliance	Description	Data
N/A	Ramp Length (in)	46.0	No	Ramp Slope (%)	10.1
Yes	Ramp Width (in)	50.0	No	Ramp XSlope (%)	6.6
N/A	Flare Type LT	N/A	N/A	Flare Type RT	N/A
N/A	Flare Slope LT (%)	N/A	N/A	Flare Slope RT (%)	N/A
N/A	Flare Traversable LT?	N/A	N/A	Flare Traversable RT?	N/A
N/A	Landing Length (in)	N/A	N/A	DWS Provided?	N/A
N/A	Landing Width (in)	N/A	N/A	DWS Contrast?	N/A
N/A	Landing Slope (%)	N/A	N/A	DWS Length (in)	N/A
N/A	Landing X Slope (%)	N/A	N/A	DWS Full Width?	N/A
N/A	Landing Curb? (Y/N)	N/A	N/A	DWS Offset (in)	N/A
N/A	Shared Landing?	N/A			
N/A	Gutter Ponding?	N/A	N/A	Gutter Slope (%)	N/A
N/A	Gutter Lip Ht (in)	N/A	N/A	Gutter X Slope (%)	N/A
N/A	Painted X Walk1?	No	N/A	Painted X Walk2?	No
	X Walk 1 Direction	To W		X Walk 2 Direction	To S
N/A	X Walk 1 Width (in)	N/A	N/A	X Walk 2 Width (in)	N/A
	X Walk 1 Slope (%)	3.2		X Walk 2 Slope (%)	3.0
	X Walk 1 X Slope (%)	3.8		X Walk 2 X Slope (%)	6.5

N/A	Ramp inside XWalk1?	N/A	N/A	Ramp inside XWalk2?	N/A
	Road Slope (%)	2.7	N/A	Clear Space?	N/A
	Road X Slope (%)	2.3	N/A	Clear Space to XWalk (in)	N/A
N/A	Any Obstructions?	N/A	N/A	Storm Grate/Utility Hazard?	N/A
	Obstruction Type			Storm Grate/Utility Type	
		N/A			N/A
		Yes		Surface Condition? (G/P)	Good

**Remove & Replace Curb Ramp With Two New Directional Ramps or Equivalent.**

Total Cost: \$ 3200.00
