Access Compliance Report

Public Rights-of-Way

(Curb Ramps)

Intersection ID: 53284	Main Street: BENFIELD_RD	Cross Street: ROBERT_HELMS_RD	Location: E
ADA ID: 76898C9804B0	Ramp Type: Perp	Initial Pass/Fail: Pass	Overall Compliance: No
Severity Score: 0			
Codes/Mitigation Info/Possible Solution		Field Measurements/Component Compliance

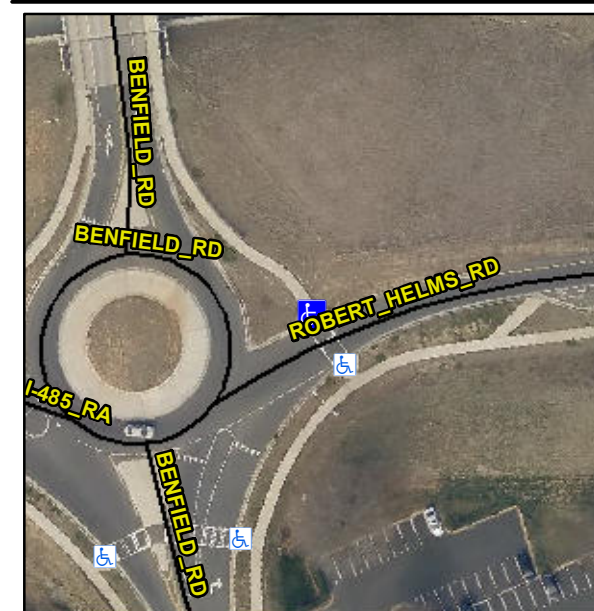
Compliance	Description	Data	Compliance	Description	Data
N/A	Ramp Length (in)	91.0	Yes	Ramp Slope (%)	5.1
Yes	Ramp Width (in)	48.0	Yes	Ramp XSlope (%)	0.1
N/A	Flare Type LT	Sloped	N/A	Flare Type RT	N/A
N/A	Flare Slope LT (%)	5.3	N/A	Flare Slope RT (%)	5.8
N/A	Flare Traversable LT?	No	N/A	Flare Traversable RT?	No
Yes	Landing Length (in)	56.0	Yes	DWS Provided?	Yes
Yes	Landing Width (in)	77.0	Yes	DWS Contrast?	Yes
Yes	Landing Slope (%)	1.2	Yes	DWS Length (in)	24.0
Yes	Landing X Slope (%)	1.6	Yes	DWS Full Width?	Yes
N/A	Landing Curb? (Y/N)	No	No	DWS Offset (in)	5.5
N/A	Shared Landing?	No			
Yes	Gutter Ponding?	No	Yes	Gutter Slope (%)	0.1
Yes	Gutter Lip Ht (in)	0.0	Yes	Gutter X Slope (%)	0.2
N/A	Painted X Walk1?	Yes	N/A	Painted X Walk2?	N/A
	X Walk 1 Direction	To S		X Walk 2 Direction	N/A
N/A	X Walk 1 Width (in)	105.0	N/A	X Walk 2 Width (in)	N/A
	X Walk 1 Slope (%)	0.5		X Walk 2 Slope (%)	N/A
	X Walk 1 X Slope (%)	0.1		X Walk 2 X Slope (%)	N/A

Yes	Ramp inside XWalk1?	Yes	N/A	Ramp inside XWalk2?	N/A
	Road Slope (%)	N/A	N/A	Clear Space?	Yes
	Road X Slope (%)	N/A	N/A	Clear Space to XWalk (in)	N/A
Yes	Any Obstructions?	No	Yes	Storm Grate/Utility Hazard?	No
	Obstruction Type			Storm Grate/Utility Type	
		N/A			N/A
			Yes	Surface Condition? (G/P)	Good

Remove & Replace Detectable Warning System.

R305.2
