Access Compliance Report

Public Rights-of-Way

(Curb Ramps)

Intersection ID: 44446	Main Street: REAMES_RD	Cross Street: PRESTBURY_BV	Location: SE
ADA ID: 768B0E217674	Ramp Type: PerpDiag	Initial Pass/Fail: Fail	Overall Compliance: No
Severity Score: 12.5			
Codes/Mitigation Info/Possible Solution		Field Measurements/Component Compliance

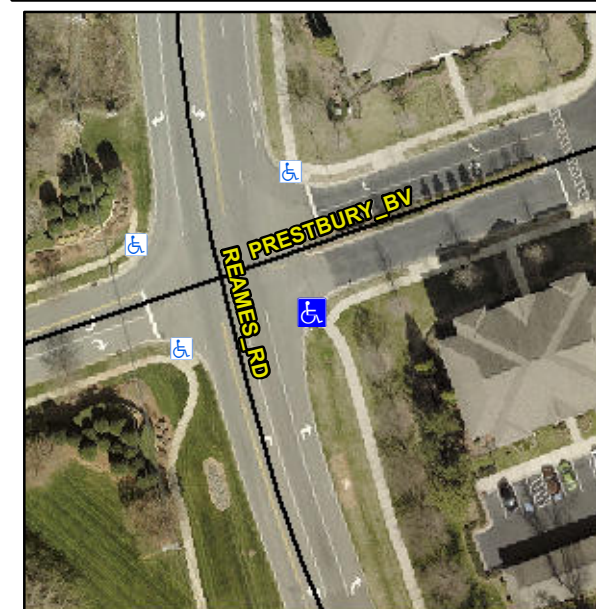
Not Found, R304.5.3

Compliance	Description	Data	Compliance	Description	Data
N/A	Ramp Length (in)	70.0	Yes	Ramp Slope (%)	5.8
Yes	Ramp Width (in)	48.0	No	Ramp XSlope (%)	5.5
N/A	Flare Type LT	N/A	N/A	Flare Type RT	N/A
N/A	Flare Slope LT (%)	N/A	N/A	Flare Slope RT (%)	N/A
N/A	Flare Traversable LT?	N/A	N/A	Flare Traversable RT?	N/A
N/A	Landing Length (in)	N/A	N/A	DWS Provided?	N/A
N/A	Landing Width (in)	N/A	N/A	DWS Contrast?	N/A
N/A	Landing Slope (%)	N/A	N/A	DWS Length (in)	N/A
N/A	Landing X Slope (%)	N/A	N/A	DWS Full Width?	N/A
N/A	Landing Curb? (Y/N)	N/A	N/A	DWS Offset (in)	N/A
N/A	Shared Landing?	N/A			
N/A	Gutter Ponding?	N/A	N/A	Gutter Slope (%)	N/A
N/A	Gutter Lip Ht (in)	N/A	N/A	Gutter X Slope (%)	N/A
N/A	Painted X Walk1?	No	N/A	Painted X Walk2?	No
	X Walk 1 Direction	To N		X Walk 2 Direction	To W
N/A	X Walk 1 Width (in)	N/A	N/A	X Walk 2 Width (in)	N/A
	X Walk 1 Slope (%)	2.5		X Walk 2 Slope (%)	3.8
	X Walk 1 X Slope (%)	4.7		X Walk 2 X Slope (%)	3.9

N/A	Ramp inside XWalk1?	N/A	N/A	Ramp inside XWalk2?	N/A
	Road Slope (%)	0.2	N/A	Clear Space?	N/A
	Road X Slope (%)	6.3	N/A	Clear Space to XWalk (in)	N/A
N/A	Any Obstructions?	N/A	N/A	Storm Grate/Utility Hazard?	N/A
	Obstruction Type			Storm Grate/Utility Type	
		N/A			N/A
		Yes		Surface Condition? (G/P)	Good

Remove & Replace Curb Ramp With Two New Directional Ramps or Equivalent.
