Access Compliance Report

Public Rights-of-Way

(Curb Ramps)

Intersection ID: 53804	Main Street: NATHAN_DR	Cross Street: PITZER_DR	Location: S
ADA ID: 768BE11F46A5	Ramp Type: Perp	Initial Pass/Fail: Fail	Overall Compliance: No
			Severity Score: 26.25

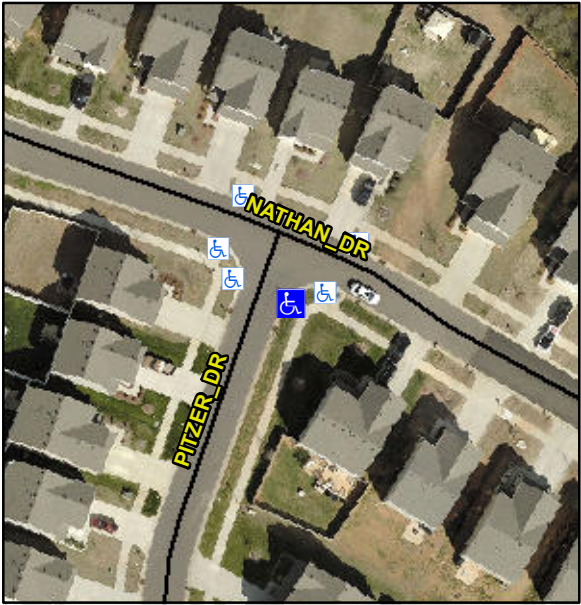
Possible Solutions:		Compliance	Description	Data
	Remove & Replace Entire Ramp.		No	Ramp Length (in)	95.5
			Yes	Ramp Width (in)	59.0
			N/A	Flare Type LT	N/A
			N/A	Flare Slope LT (%)	N/A
			N/A	Flare Traversable LT?	N/A
			N/A	Landing Length (in)	N/A
			N/A	Landing Width (in)	N/A
			N/A	Landing Slope (%)	N/A
			N/A	Landing X Slope (%)	N/A
<p>Surveyor Notes:</p> <p>N/A</p> <p>PROW/ADA:</p> <p>Not Found, R304.2.2, R304.5.3</p>			N/A	Flare Type RT	N/A
			N/A	Flare Slope RT (%)	N/A
			N/A	Flare Traversable RT?	N/A
			N/A	DWS Provided?	N/A
			N/A	DWS Contrast?	N/A
			N/A	DWS Length (in)	N/A
			N/A	DWS Full Width?	N/A
			N/A	DWS Offset (in)	N/A
			N/A	Gutter Ponding?	Yes
			N/A	Gutter Lip Ht (in)	N/A
			No	Painted X Walk1?	N/A
			To NW	X Walk 1 Direction	N/A
			N/A	X Walk 1 Width (in)	N/A

4.4	X Walk 1 Slope (%)	N/A
			3.5	X Walk 1 X Slope (%)	N/A
			N/A	Ramp inside XWalk1?	N/A
			N/A	Road Slope (%)	N/A
			N/A	Road X Slope (%)	N/A
			N/A	Any Obstructions?	N/A
				Obstruction Type	N/A
Total Cost:			\$ 1850.00		
			N/A		N/A
			Yes	Surface Condition? (G/P)	Good
