# Access Compliance Report

## Public Rights-of-Way

### (Curb Ramps)

Intersection ID: 18847	Main Street: BRACE_RD	Cross Street: RAMA_RD	Location: S
ADA ID: 768C839B2685	Ramp Type: PerpDiag	Initial Pass/Fail: Fail	Overall Compliance: No
Codes/Mitigation Info/Possible Solution		Field Measurements/Component Compliance

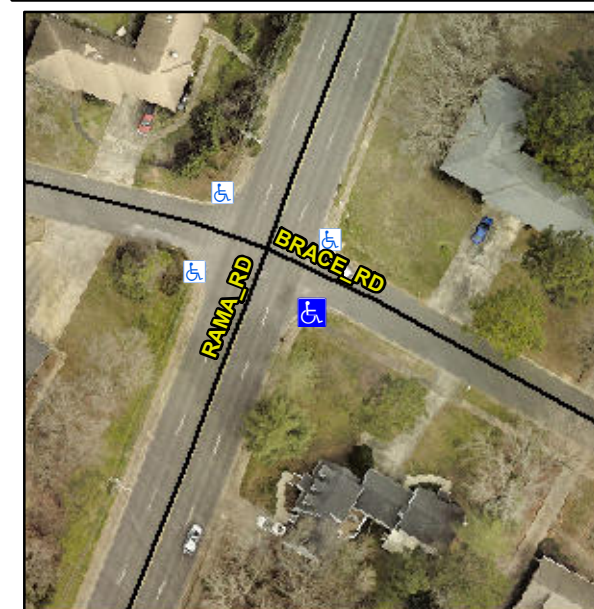
**Not Found, R304.5.1, R304.2.2**

Compliance	Description	Data	Compliance	Description	Data
N/A	Ramp Length (in)	69.0	No	Ramp Slope (%)	9.0
No	Ramp Width (in)	44.0	Yes	Ramp XSlope (%)	1.3
N/A	Flare Type LT	N/A	N/A	Flare Type RT	N/A
N/A	Flare Slope LT (%)	N/A	N/A	Flare Slope RT (%)	N/A
N/A	Flare Traversable LT?	N/A	N/A	Flare Traversable RT?	N/A
N/A	Landing Length (in)	N/A	N/A	DWS Provided?	N/A
N/A	Landing Width (in)	N/A	N/A	DWS Contrast?	N/A
N/A	Landing Slope (%)	N/A	N/A	DWS Length (in)	N/A
N/A	Landing X Slope (%)	N/A	N/A	DWS Full Width?	N/A
N/A	Landing Curb? (Y/N)	N/A	N/A	DWS Offset (in)	N/A
N/A	Shared Landing?	N/A			
N/A	Gutter Ponding?	N/A	N/A	Gutter Slope (%)	N/A
N/A	Gutter Lip Ht (in)	N/A	N/A	Gutter X Slope (%)	N/A
N/A	Painted X Walk1?	No	N/A	Painted X Walk2?	No
	X Walk 1 Direction	To NE		X Walk 2 Direction	To NW
N/A	X Walk 1 Width (in)	N/A	N/A	X Walk 2 Width (in)	N/A
	X Walk 1 Slope (%)	1.1		X Walk 2 Slope (%)	2.6
	X Walk 1 X Slope (%)	3.2		X Walk 2 X Slope (%)	0.8

N/A	Ramp inside XWalk1?	N/A	N/A	Ramp inside XWalk2?	N/A
	Road Slope (%)	2.5	N/A	Clear Space?	N/A
	Road X Slope (%)	1.7	N/A	Clear Space to XWalk (in)	N/A
N/A	Any Obstructions?	N/A	N/A	Storm Grate/Utility Hazard?	N/A
	Obstruction Type			Storm Grate/Utility Type	
		N/A			N/A
			Yes	Surface Condition? (G/P)	Good

**Remove & Replace Curb Ramp With Two New Directional Ramps or Equivalent.**
