Access Compliance Report

Public Rights-of-Way

(Curb Ramps)

| Intersection ID: 14994 | Main Street: OLD_MEADOW_RD | Cross Street: SHACKLEFORD_TR | Location: SW |

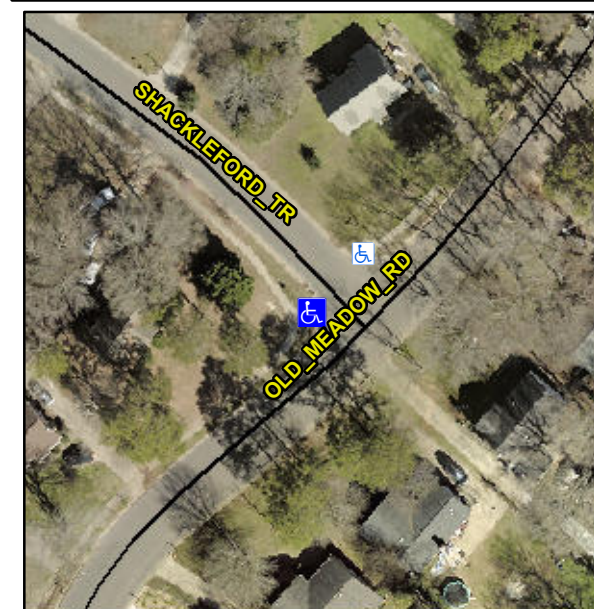
| ADA ID: 76A23E5F2741 | Ramp Type: PerpDiag | Initial Pass/Fail: Fail | Overall Compliance: No |
| Severity Score: 8.75 | | | |

Not Found, R304.5.1

| Compliance | Description | Data | Compliance | Description | Data |
|---|---|---|---|---|---|
| No | Ramp Width (in) | 47.0 | Yes | Ramp XSlope (%) | 1.6 |

Remove & Replace Curb Ramp With Two New Directional Ramps or Equivalent.
