# Access Compliance Report

## Public Rights-of-Way

### (Curb Ramps)

Intersection ID: 23150	Main Street: ALEXANDER_RD	Cross Street: BELLEMEADE_LN	Location: SE
ADA ID: 76A338365D73	Ramp Type: Directional1	Initial Pass/Fail: Fail	Overall Compliance: No
		Severity Score: 1.25

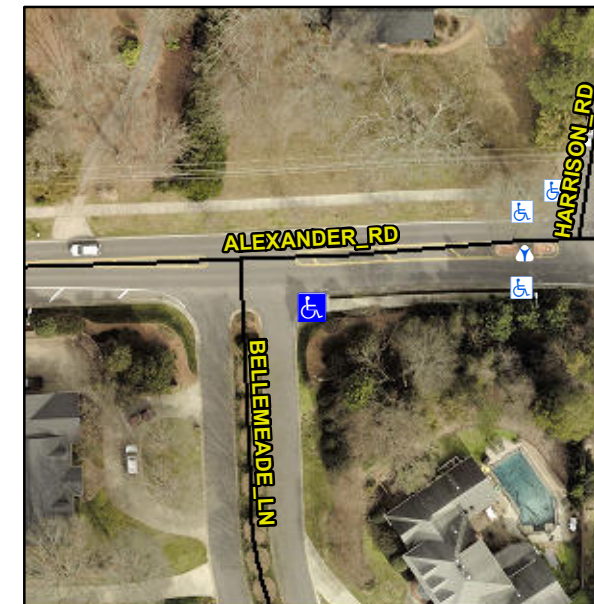
Compliance	Description	Data	Compliance	Description	Data
N/A	Ramp Length (in)	83.0	N/A	Grade Break?	N/A
Yes	Ramp Width (in)	70.5	N/A	Grade Break Slope (%)	0.0
Yes	Ramp Slope (%)	5.9	N/A	Grade Break XSlope (%)	0.0
No	Ramp XSlope (%)	2.4			
N/A	Flare Type LT	N/A	N/A	Flare Type RT	N/A
N/A	Flare Slope LT (%)	N/A	N/A	Flare Slope RT (%)	0.0
N/A	Flare Traversable LT?	N/A	N/A	Flare Traversable RT?	N/A
N/A	Landing Length (in)	0.0	N/A	DWS Provided?	N/A
N/A	Landing Width (in)	0.0	N/A	DWS Contrast?	N/A
N/A	Landing Slope (%)	0.0	N/A	DWS Length (in)	N/A
N/A	Landing X Slope (%)	0.0	N/A	DWS Full Width?	N/A
N/A	Landing Curb? (Y/N)	N/A	N/A	DWS Offset LT (in)	N/A
N/A	Shared Landing?	N/A	N/A	DWS Offset RT (in)	N/A
N/A	Gutter Ponding?	0.0	N/A	Gutter Slope (%)	N/A
N/A	Gutter Lip Ht (in)	0.0	N/A	Gutter X Slope (%)	N/A
N/A	Painted X Walk1?	No		Road Slope (%)	0.7
	X Walk 1 Direction	To W		Road X Slope (%)	5.0
	X Walk 1 Width (in)	N/A		Clear Space?	N/A

X Walk 1 Slope (%)	0.7	N/A	Clear Space to XWalk (in)	N/A
	X Walk 1 X Slope (%)	5.0	N/A	Storm Grate/Utility Hazard?	N/A
N/A	Ramp inside XWalk1?	N/A		Storm Grate/Utility Type	
N/A	Any Obstructions?	N/A			N/A
	Obstruction Type		Yes	Surface Condition? (G/P)	Good
			N/A	Curb Slope (%)	15.4

**Remove & Replace Entire Ramp.**

**R304.5.3**

\$ 1600.00
