Access Compliance Report

Public Rights-of-Way

(Curb Ramps)

Intersection ID: 31302	Main Street: BOYNE_RD	Cross Street: EBEN_DR	Location:	N
ADA ID: 76A3D1001EB4	Ramp Type: PerpDiag	Initial Pass/Fail: Fail	Overall Compliance: No	Severity Score: 22.5
Codes/Mitigation Info/Possible Solution		Field Measurements/Component Compliance

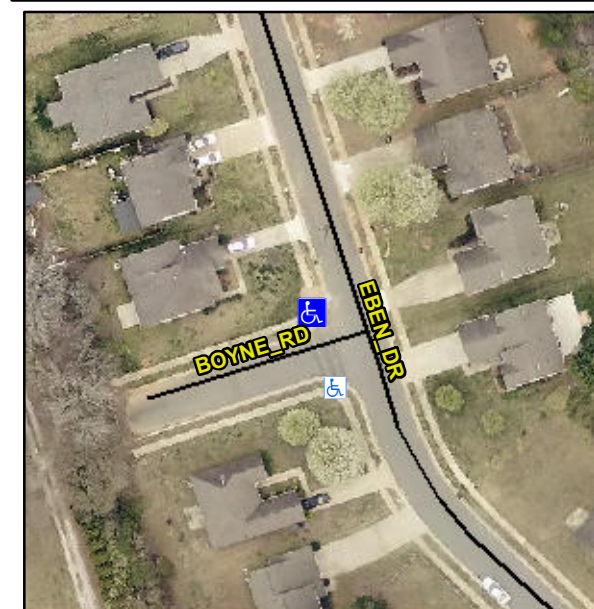
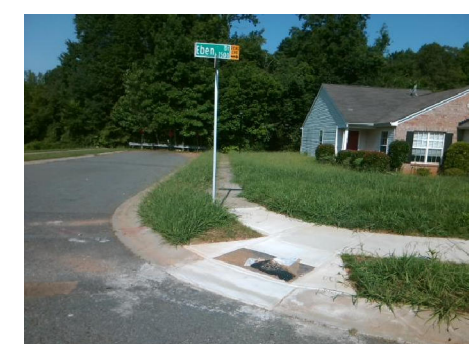
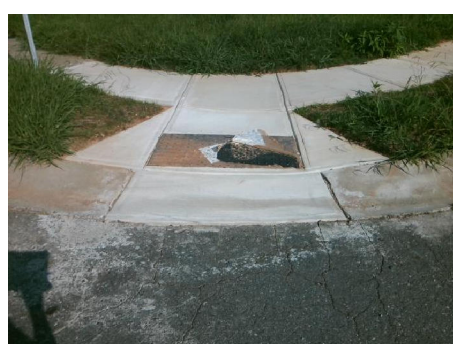
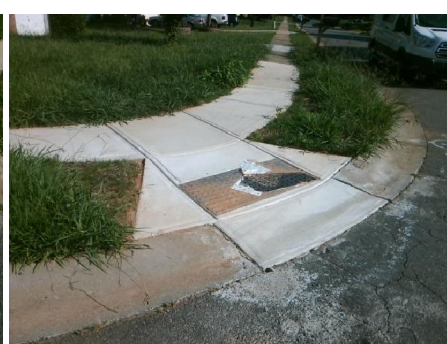
Not Found, R304.5.1, R304.2.2, R304.5.3

Compliance	Description	Data	Compliance	Description	Data
N/A	Ramp Length (in)	50.0	No	Ramp Slope (%)	11.6
No	Ramp Width (in)	45.5	No	Ramp XSlope (%)	4.4
N/A	Flare Type LT	N/A	N/A	Flare Type RT	N/A
N/A	Flare Slope LT (%)	N/A	N/A	Flare Slope RT (%)	N/A
N/A	Flare Traversable LT?	N/A	N/A	Flare Traversable RT?	N/A
N/A	Landing Length (in)	N/A	N/A	DWS Provided?	N/A
N/A	Landing Width (in)	N/A	N/A	DWS Contrast?	N/A
N/A	Landing Slope (%)	N/A	N/A	DWS Length (in)	N/A
N/A	Landing X Slope (%)	N/A	N/A	DWS Full Width?	N/A
N/A	Landing Curb? (Y/N)	N/A	N/A	DWS Offset (in)	N/A
N/A	Shared Landing?	N/A			
N/A	Gutter Ponding?	N/A	N/A	Gutter Slope (%)	N/A
N/A	Gutter Lip Ht (in)	N/A	N/A	Gutter X Slope (%)	N/A
N/A	Painted X Walk1?	No	N/A	Painted X Walk2?	No
	X Walk 1 Direction	To S		X Walk 2 Direction	To E
N/A	X Walk 1 Width (in)	N/A	N/A	X Walk 2 Width (in)	N/A
	X Walk 1 Slope (%)	1.6		X Walk 2 Slope (%)	3.8
	X Walk 1 X Slope (%)	4.2		X Walk 2 X Slope (%)	2.2

N/A	Ramp inside XWalk1?	N/A	N/A	Ramp inside XWalk2?	N/A
	Road Slope (%)	2.5	N/A	Clear Space?	N/A
	Road X Slope (%)	0.8	N/A	Clear Space to XWalk (in)	N/A
N/A	Any Obstructions?	N/A	N/A	Storm Grate/Utility Hazard?	N/A
	Obstruction Type			Storm Grate/Utility Type	
		N/A			N/A
			Yes	Surface Condition? (G/P)	Good

Remove & Replace Curb Ramp With Two New Directional Ramps or Equivalent.
