Access Compliance Report

Public Rights-of-Way

(Curb Ramps)

Intersection ID: 7038	Main Street: BROOKWOOD_RD	Cross Street: WOODWIND_ST	Location: NW
ADA ID: 76A4D091AE1F	Ramp Type: Perp	Initial Pass/Fail: Fail	Overall Compliance: No
		Severity Score: 10

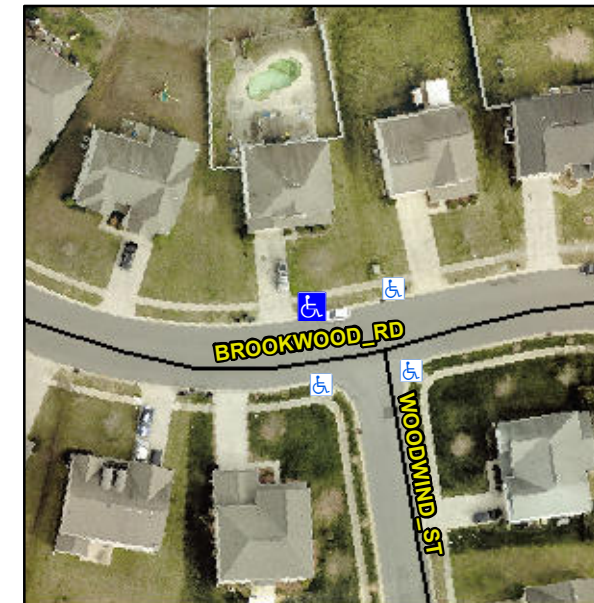
Not Found, R304.5.1

Compliance	Description	Data	Compliance	Description	Data
N/A	Ramp Length (in)	72.0	Yes	Ramp Slope (%)	6.0
No	Ramp Width (in)	47.5	Yes	Ramp XSlope (%)	2.4
N/A	Flare Type LT	N/A	N/A	Flare Type RT	N/A
N/A	Flare Slope LT (%)	N/A	N/A	Flare Slope RT (%)	N/A
N/A	Flare Traversable LT?	N/A	N/A	Flare Traversable RT?	N/A
N/A	Landing Length (in)	N/A	N/A	DWS Provided?	N/A
N/A	Landing Width (in)	N/A	N/A	DWS Contrast?	N/A
N/A	Landing Slope (%)	N/A	N/A	DWS Length (in)	N/A
N/A	Landing X Slope (%)	N/A	N/A	DWS Full Width?	N/A
N/A	Landing Curb? (Y/N)	N/A	N/A	DWS Offset (in)	N/A
N/A	Shared Landing?	N/A			
N/A	Gutter Ponding?	N/A	N/A	Gutter Slope (%)	N/A
N/A	Gutter Lip Ht (in)	N/A	N/A	Gutter X Slope (%)	N/A
N/A	Painted X Walk1?	No	N/A	Painted X Walk2?	N/A
	X Walk 1 Direction	To S		X Walk 2 Direction	N/A
N/A	X Walk 1 Width (in)	N/A	N/A	X Walk 2 Width (in)	N/A
	X Walk 1 Slope (%)	4.2		X Walk 2 Slope (%)	N/A
	X Walk 1 X Slope (%)	3.0		X Walk 2 X Slope (%)	N/A

N/A	Ramp inside XWalk1?	N/A	N/A	Ramp inside XWalk2?	N/A
	Road Slope (%)	N/A	N/A	Clear Space?	N/A
	Road X Slope (%)	N/A	N/A	Clear Space to XWalk (in)	N/A
N/A	Any Obstructions?	N/A	N/A	Storm Grate/Utility Hazard?	N/A
	Obstruction Type			Storm Grate/Utility Type	
		N/A			N/A
			Yes	Surface Condition? (G/P)	Good

Remove & Replace Entire Ramp.

Total Cost: \$ 1850.00
