# Access Compliance Report

## Public Rights-of-Way

### (Curb Ramps)

Intersection ID: 10015635	Main Street: HARRIS_CORNERS_PY	Cross Street: N/A	Location: NE
ADA ID: 76AEDD72A3AE	Ramp Type: Perp	Initial Pass/Fail: Fail	Overall Compliance: No
Severity Score: 25			
Codes/Mitigation Info/Possible Solution		Field Measurements/Component Compliance

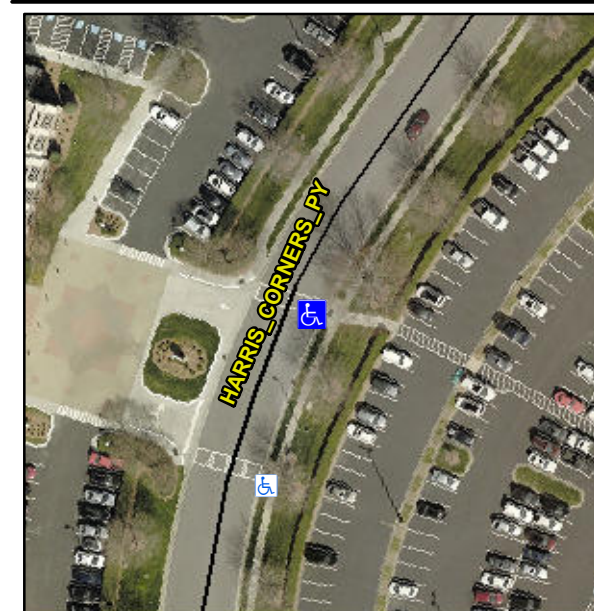
**Not Found, R304.2.2**

Compliance	Description	Data	Compliance	Description	Data
N/A	Ramp Length (in)	46.0	No	Ramp Slope (%)	14.6
Yes	Ramp Width (in)	48.0	Yes	Ramp XSlope (%)	0.7
N/A	Flare Type LT	N/A	N/A	Flare Type RT	N/A
N/A	Flare Slope LT (%)	N/A	N/A	Flare Slope RT (%)	N/A
N/A	Flare Traversable LT?	N/A	N/A	Flare Traversable RT?	N/A
N/A	Landing Length (in)	N/A	N/A	DWS Provided?	N/A
N/A	Landing Width (in)	N/A	N/A	DWS Contrast?	N/A
N/A	Landing Slope (%)	N/A	N/A	DWS Length (in)	N/A
N/A	Landing X Slope (%)	N/A	N/A	DWS Full Width?	N/A
N/A	Landing Curb? (Y/N)	N/A	N/A	DWS Offset (in)	N/A
N/A	Shared Landing?	N/A			
N/A	Gutter Ponding?	N/A	N/A	Gutter Slope (%)	N/A
N/A	Gutter Lip Ht (in)	N/A	N/A	Gutter X Slope (%)	N/A
N/A	Painted X Walk1?	Yes	N/A	Painted X Walk2?	N/A
	X Walk 1 Direction	To NW		X Walk 2 Direction	N/A
N/A	X Walk 1 Width (in)	89.0	N/A	X Walk 2 Width (in)	N/A
	X Walk 1 Slope (%)	0.0		X Walk 2 Slope (%)	N/A
	X Walk 1 X Slope (%)	0.2		X Walk 2 X Slope (%)	N/A

**Remove & Replace Entire Ramp.**

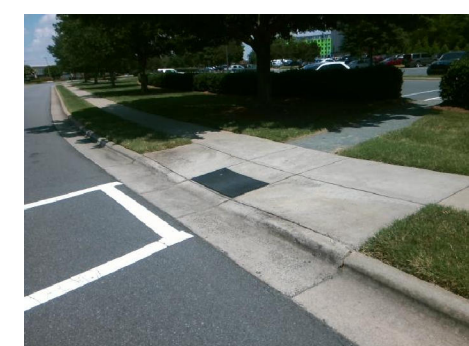
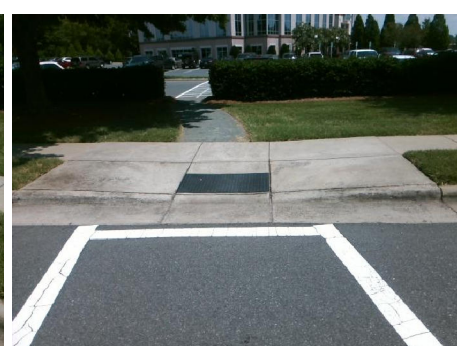
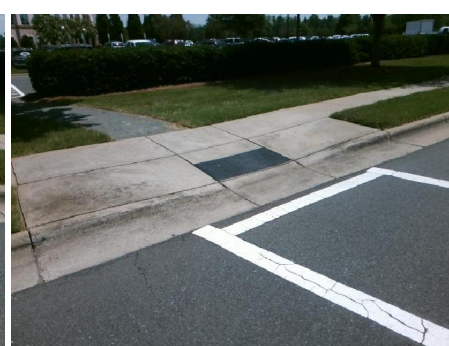
N/A	Ramp inside XWalk1?	Yes	N/A	Ramp inside XWalk2?	N/A
	Road Slope (%)	N/A	N/A	Clear Space?	N/A
	Road X Slope (%)	N/A	N/A	Clear Space to XWalk (in)	N/A
N/A	Any Obstructions?	N/A	N/A	Storm Grate/Utility Hazard?	N/A
	Obstruction Type			Storm Grate/Utility Type	
		N/A			N/A
			Yes	Surface Condition? (G/P)	Good
