Access Compliance Report

Public Rights-of-Way

(Curb Ramps)

Intersection ID: 50580	Main Street: LONGSTRAW_RD	Cross Street: PAPER_TREE_RD	Location: E
ADA ID: 76C5A23BAF8E	Ramp Type: Perp	Initial Pass/Fail: Fail	Overall Compliance: No
Severity Score: 33.75			
Codes/Mitigation Info/Possible Solution		Field Measurements/Component Compliance

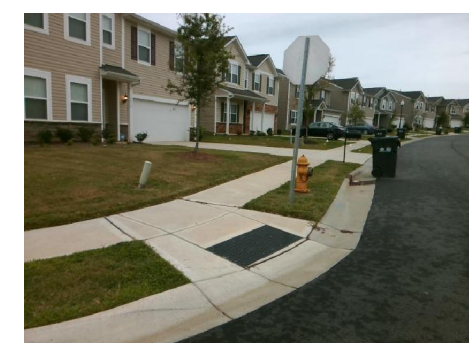
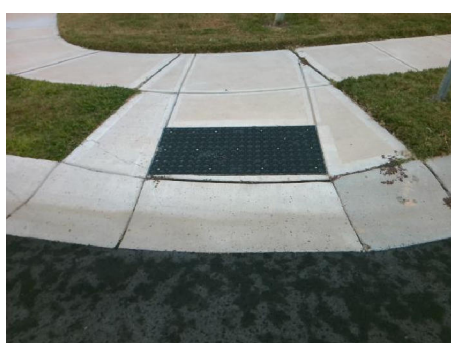
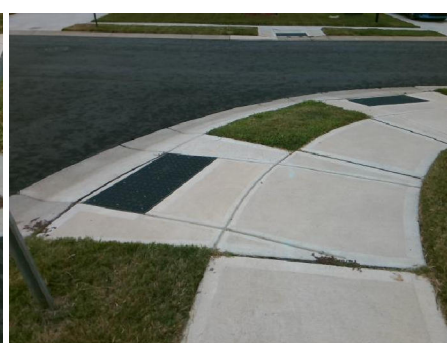
Not Found, R304.5.1, R304.2.2, R304.5.3

Compliance	Description	Data	Compliance	Description	Data
N/A	Ramp Length (in)	50.5	No	Ramp Slope (%)	10.1
No	Ramp Width (in)	47.0	No	Ramp XSlope (%)	5.3
N/A	Flare Type LT	N/A	N/A	Flare Type RT	N/A
N/A	Flare Slope LT (%)	N/A	N/A	Flare Slope RT (%)	N/A
N/A	Flare Traversable LT?	N/A	N/A	Flare Traversable RT?	N/A
N/A	Landing Length (in)	N/A	N/A	DWS Provided?	N/A
N/A	Landing Width (in)	N/A	N/A	DWS Contrast?	N/A
N/A	Landing Slope (%)	N/A	N/A	DWS Length (in)	N/A
N/A	Landing X Slope (%)	N/A	N/A	DWS Full Width?	N/A
N/A	Landing Curb? (Y/N)	N/A	N/A	DWS Offset (in)	N/A
N/A	Shared Landing?	N/A			
N/A	Gutter Ponding?	N/A	N/A	Gutter Slope (%)	N/A
N/A	Gutter Lip Ht (in)	N/A	N/A	Gutter X Slope (%)	N/A
N/A	Painted X Walk1?	No	N/A	Painted X Walk2?	N/A
	X Walk 1 Direction	To S		X Walk 2 Direction	N/A
N/A	X Walk 1 Width (in)	N/A	N/A	X Walk 2 Width (in)	N/A
	X Walk 1 Slope (%)	3.7		X Walk 2 Slope (%)	N/A
	X Walk 1 X Slope (%)	2.9		X Walk 2 X Slope (%)	N/A

N/A	Ramp inside XWalk1?	N/A	N/A	Ramp inside XWalk2?	N/A
	Road Slope (%)	N/A	N/A	Clear Space?	N/A
	Road X Slope (%)	N/A	N/A	Clear Space to XWalk (in)	N/A
N/A	Any Obstructions?	N/A	N/A	Storm Grate/Utility Hazard?	N/A
	Obstruction Type			Storm Grate/Utility Type	
		N/A			N/A
			Yes	Surface Condition? (G/P)	Good

Remove & Replace Entire Ramp.
